CLACKAMAS
WATER
ENVIRONMENT
SERVICES

BENTHIC MACROINVERTEBRATE & GEOMORPHOLOGICAL MONITORING REPORT

2024 MONITORING RESULTS

CASM ENVIRONMENTAL, LLC

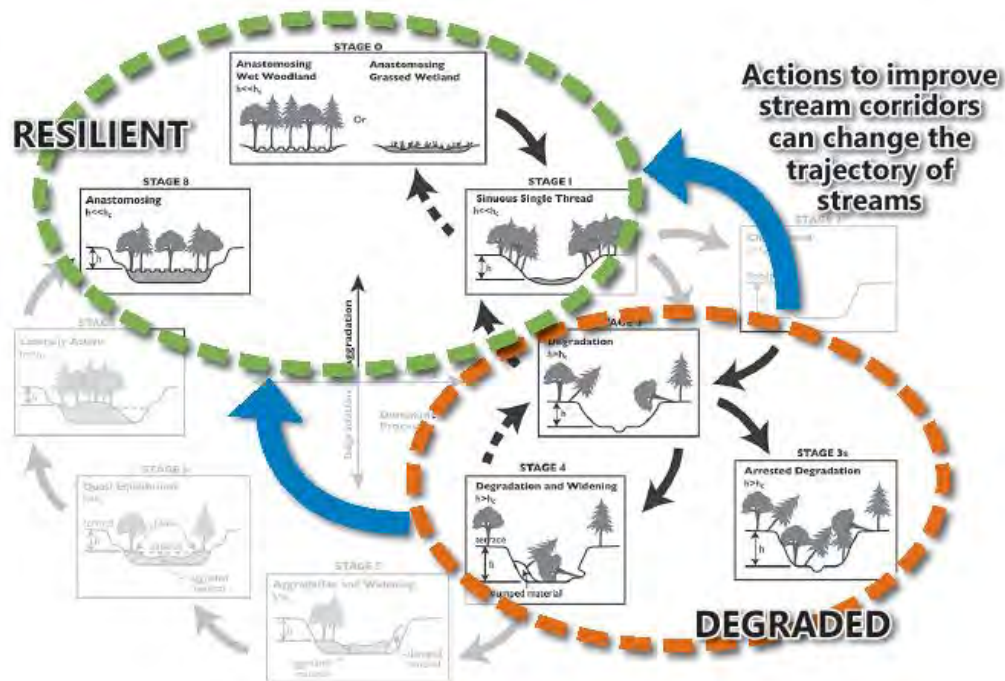
Figure 1: Channel Evolution Model (Cluer and Thorne, 2014) showing recovery pathways associated with stream resiliency.

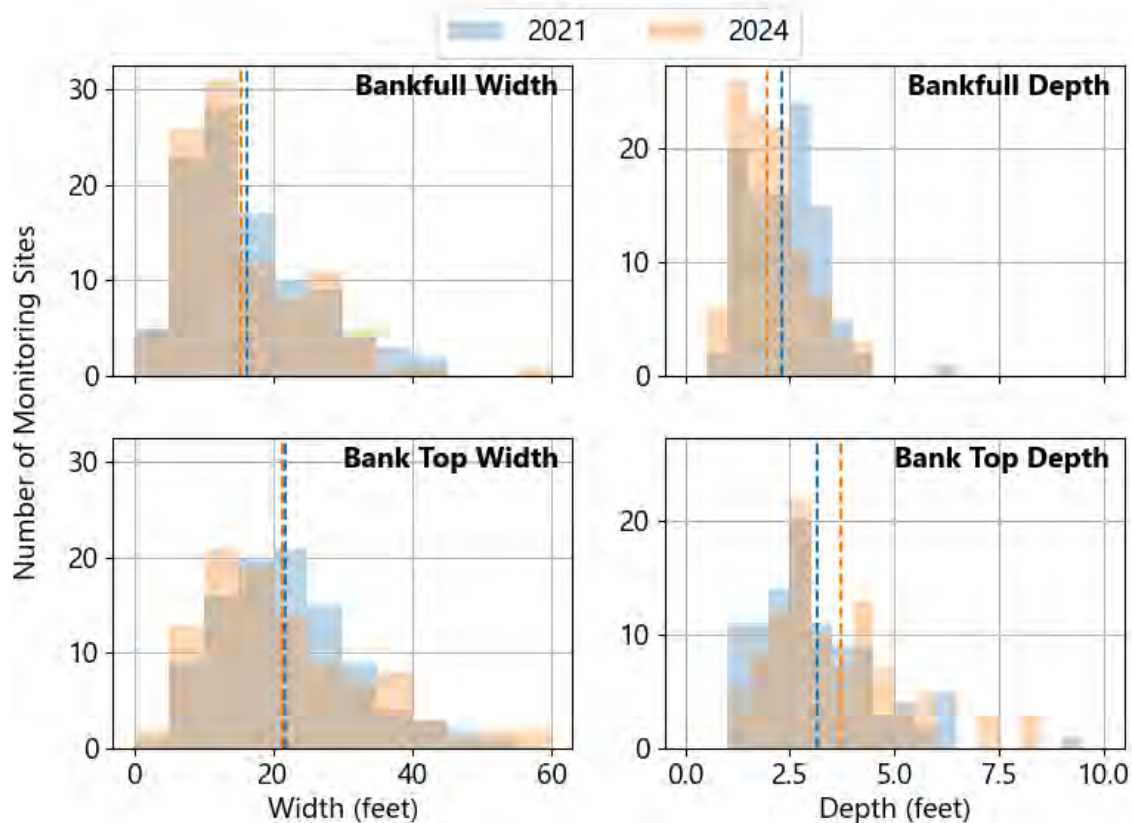
Figure 6: Histograms of measured channel geometry variables, compared between 2021 and 2024. Mean values are indicated with dashed lines.

Channel geometry measurements collected in 2021 and 2024 at 110 paired sites were used to compare changes in channel size and shape. Over a three-year period, major shifts in channel form are not typically expected, as geomorphic changes often occur over longer timescales. However, localized factors such as new development or beaver activity can cause abrupt changes in channel geometry. This comparison also serves as a check on potential observer bias in collecting relative measurements, with generally consistent values expected between 2021 and 2024. Figure 6 supports this expectation, showing little to no change in the distribution of observed channel geometry measurements as the changes in average measured value are within the standard deviations of the populations.

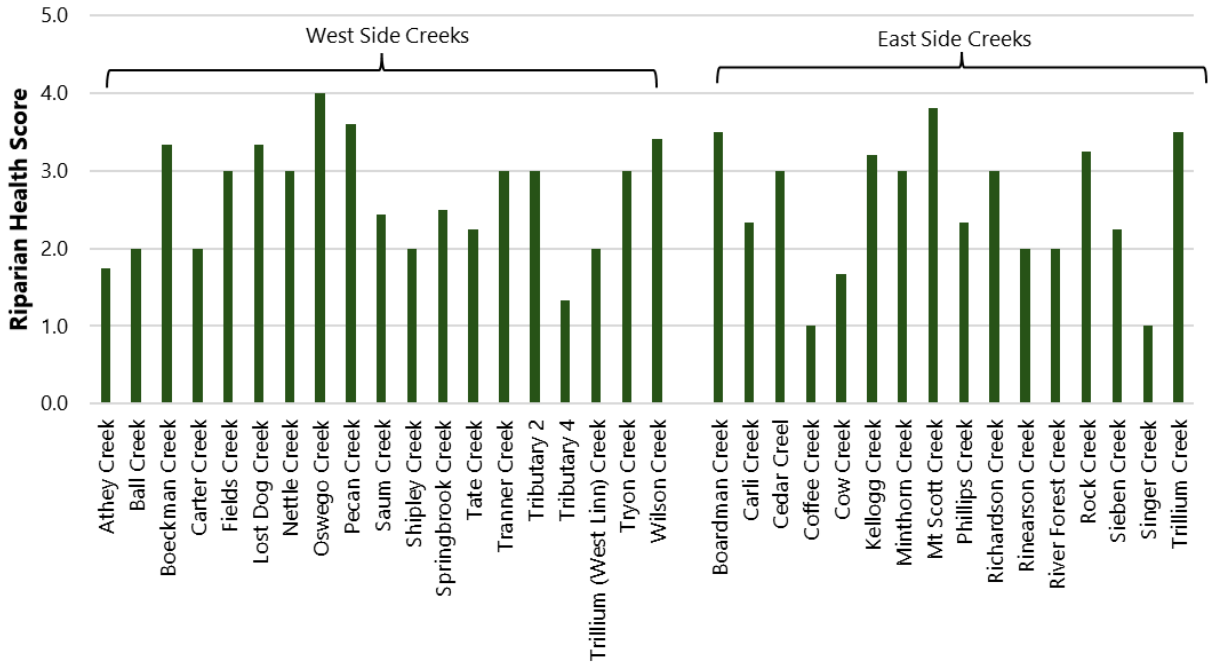
Figure 9: Summary of 2024 riparian health scoring per creek.

Overall, most creeks fall within the moderate range, scoring between 2.0 and 3.5, indicating fair riparian condition with room for improvement. Oswego Creek, Pecan Creek, Boardman Creek, Mt. Scott Creek, and Trillium (WES) Creek achieved relatively higher scores near or above 3.5, suggesting stronger riparian health. Conversely, some creeks such as Boeckman Creek, Coffee Creek, and Springbrook Creek scored below 2.0, indicating degraded riparian zones and likely limited native vegetation (Figure 9). Although riparian health was documented during the 2021 monitoring effort, differences in observation methods between years prevent direct comparison of scores across the two monitoring periods.

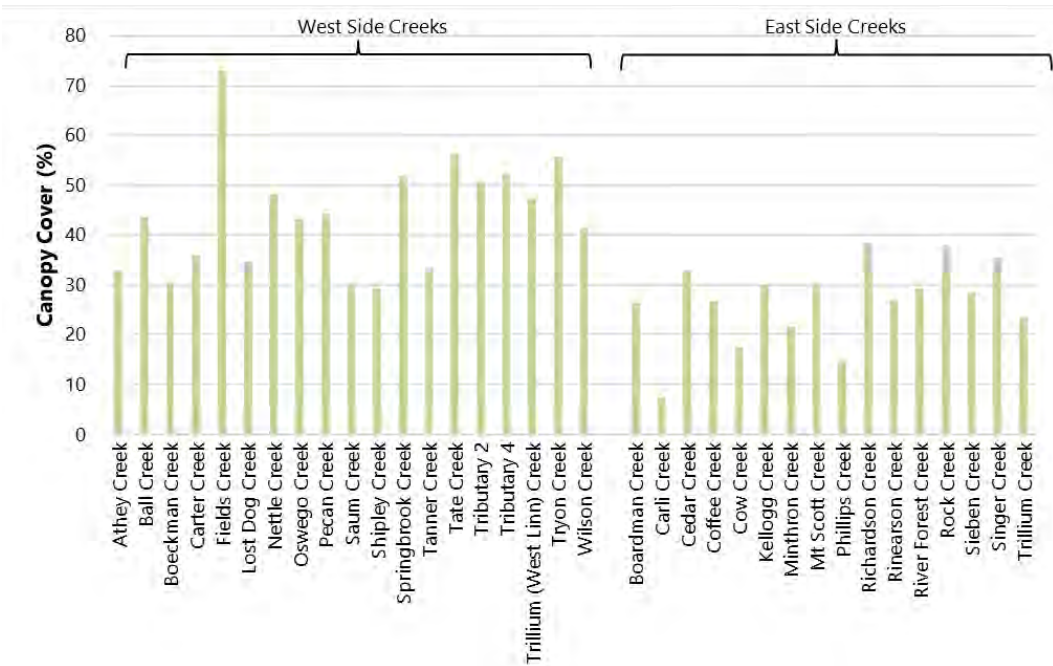
Figure 10: Percent canopy coverage per watershed from the Metro RLIS 2019 canopy raster.

Canopy cover results (Figure 10) show wide variability across sites. Fields Creek had the highest observed canopy cover at over 70 percent, followed by several sites including Tate Creek, Tryon Creek, Tributary 4, and Springbrook Creek with values above 50 percent, suggesting relatively intact riparian vegetation. In contrast, sites on Carli Creek, Phillips Creek, and Cow Creek had canopy cover below 20 percent.

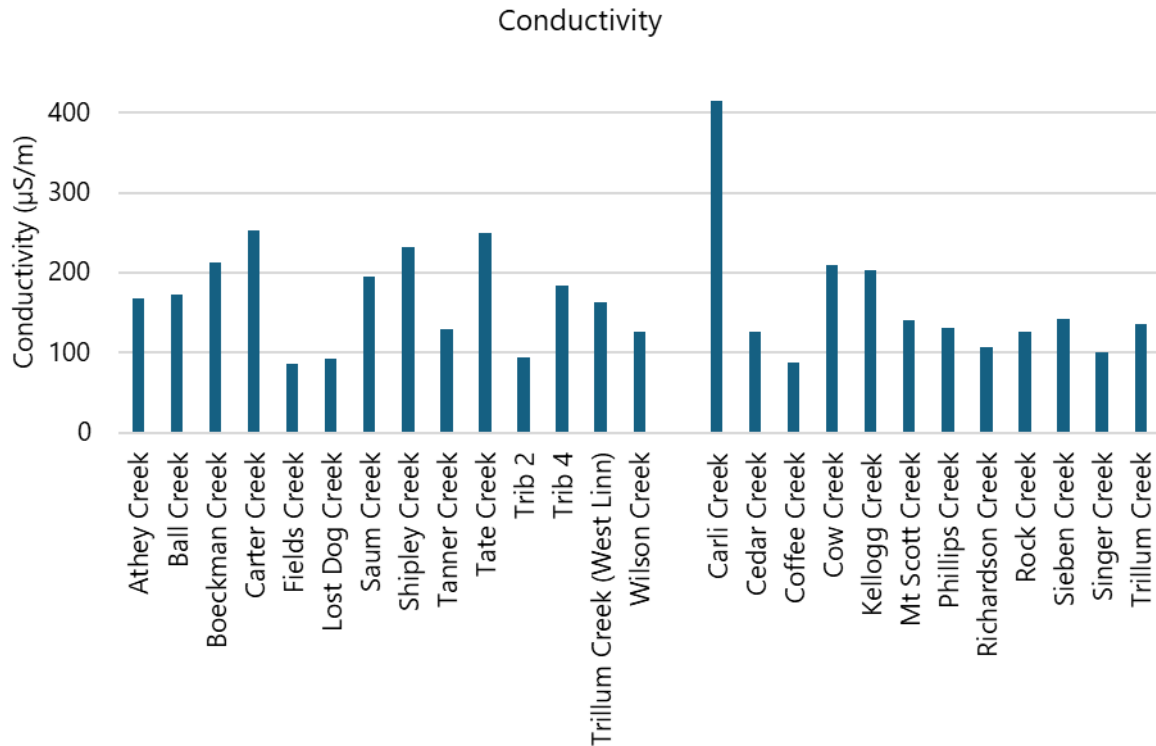
Figure 19: Conductivity results for all water quality documented streams.

In general, conductivity values between 50 and 150 $\mu\text{S}/\text{cm}$ are typical for streams in minimally impacted watersheds. Values above 150 $\mu\text{S}/\text{cm}$ may indicate underlying geologic conditions or minor human influence, while those exceeding 500 $\mu\text{S}/\text{cm}$ are often associated with more substantial pollution sources. None of the sampled streams exceeded 500 $\mu\text{S}/\text{cm}$, though Carli Creek's measurement suggests some level of anthropogenic impact.

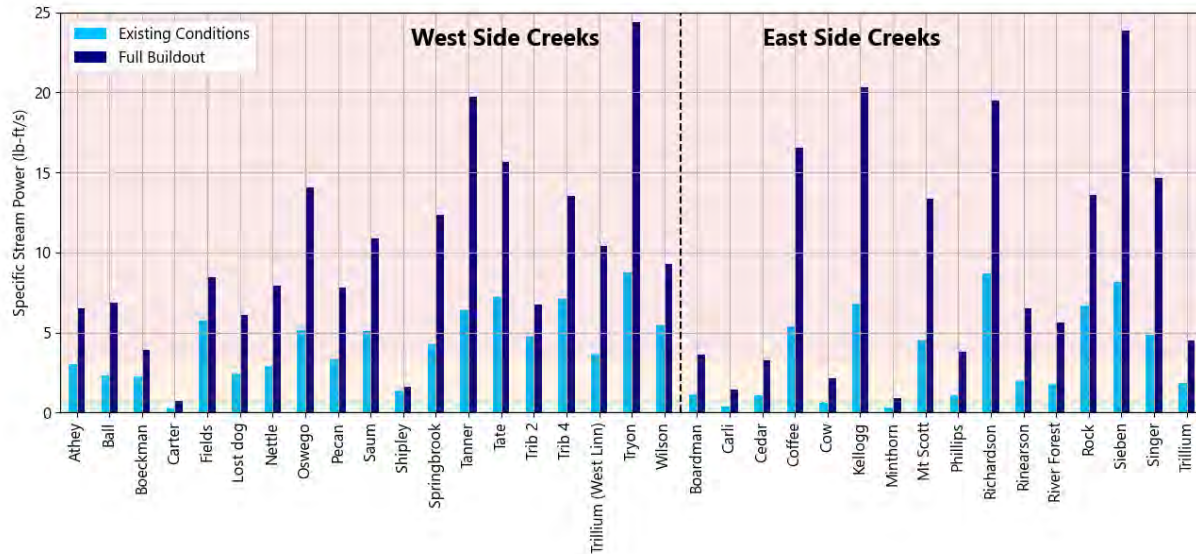
Figure 22: Stream power results for each stream under existing conditions and full buildout conditions. Green represents low erosion potential, yellow represents medium erosion potential, and red represents high erosion potential.

Specific stream power values, calculated using the hydrology described above, were used to assess erosion potential across the study area. Under existing conditions, only four streams (Carli Creek, Carter Creek, Minthorn Creek, and Cow Creek) fall within the low erosion potential category (Figure 22). Thirteen streams fall into the medium category and another eighteen fall into the high category. Tryon Creek exhibits the highest specific stream power under current conditions, with Richardson and Seiben Creeks not far behind.

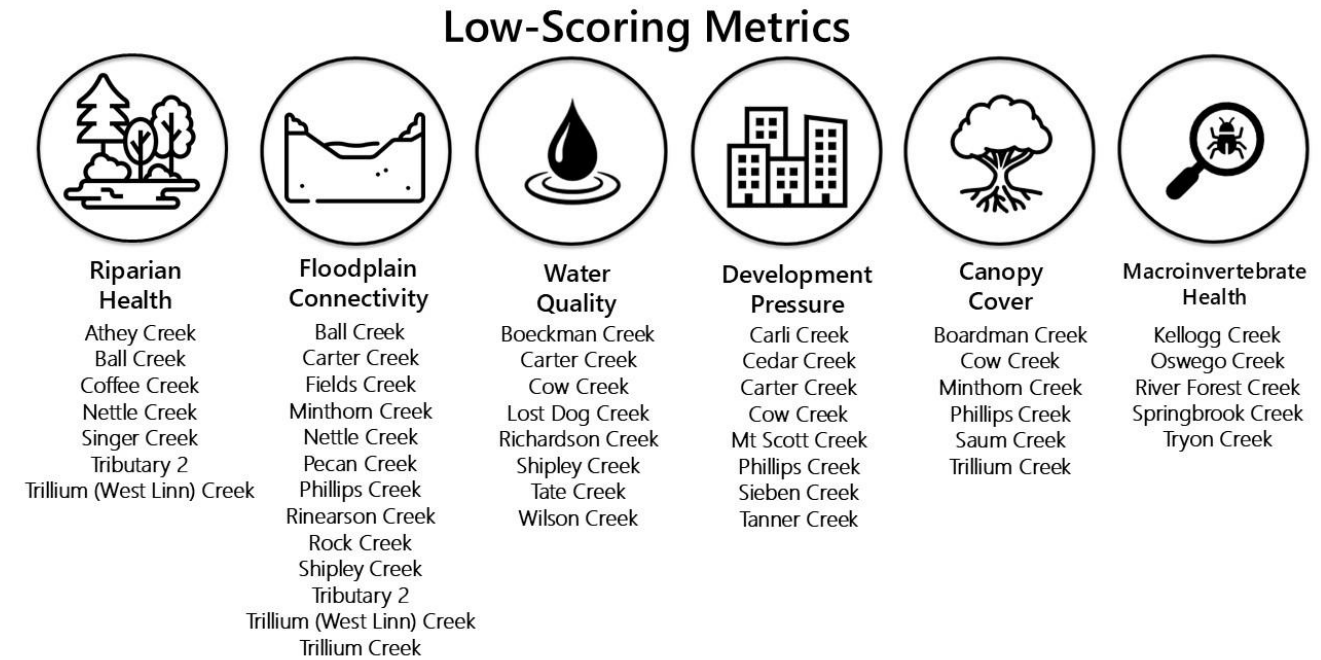
Figure 23: Graphic listing lowest scoring metric for each creek. Some creeks are listed for more than one metric.

As shown in Figure 23, floodplain connectivity is a common limiting factor, with over one-third of the streams having it as their lowest scoring metric. This is consistent with expectations for urban streams, where hydromodification increases stream energy and alters flow regimes, resulting in more frequent and intense erosive events that degrade channel and floodplain connections. Water quality is the next most frequently identified low-scoring metric, suggesting possible pollution concerns across the study area, likely influenced by stormwater runoff and other impacts associated with urbanization.

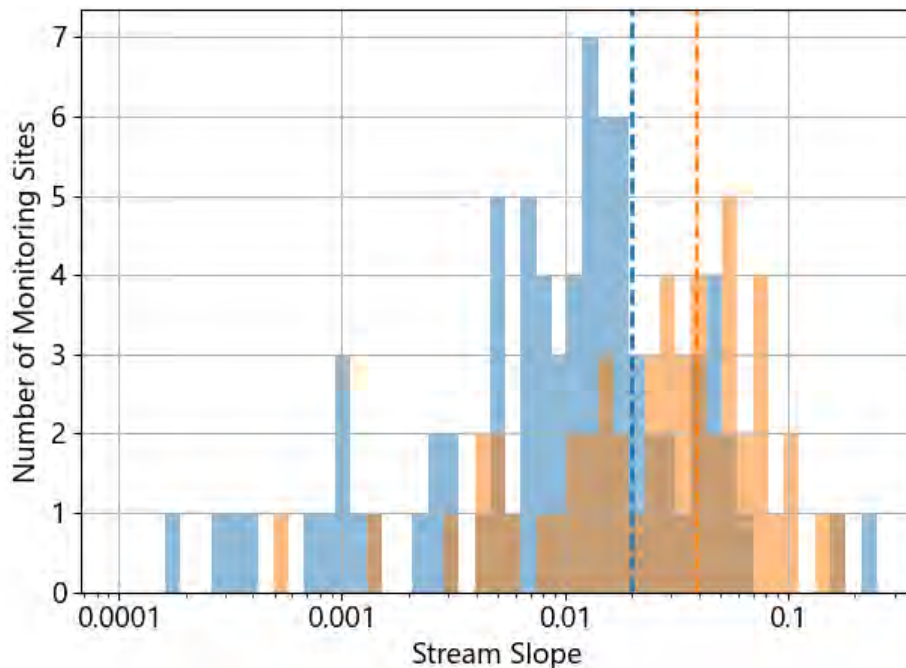
Figure 24: Histograms comparing water surface slope (ft/ft) of monitoring sites between East and West sites. Dashed lines represent the sample means.

The difference in geology and, consequently, stream slope between East and West streams is visualized in Figure 24; the average West-side stream is twice as steep (~4%) as the average East-side stream (~2%). Lower gradient streams, but not slack water, yields more hyporheic mixing, gravel substrate, and floodplain connectivity – which all benefit macroinvertebrate communities.

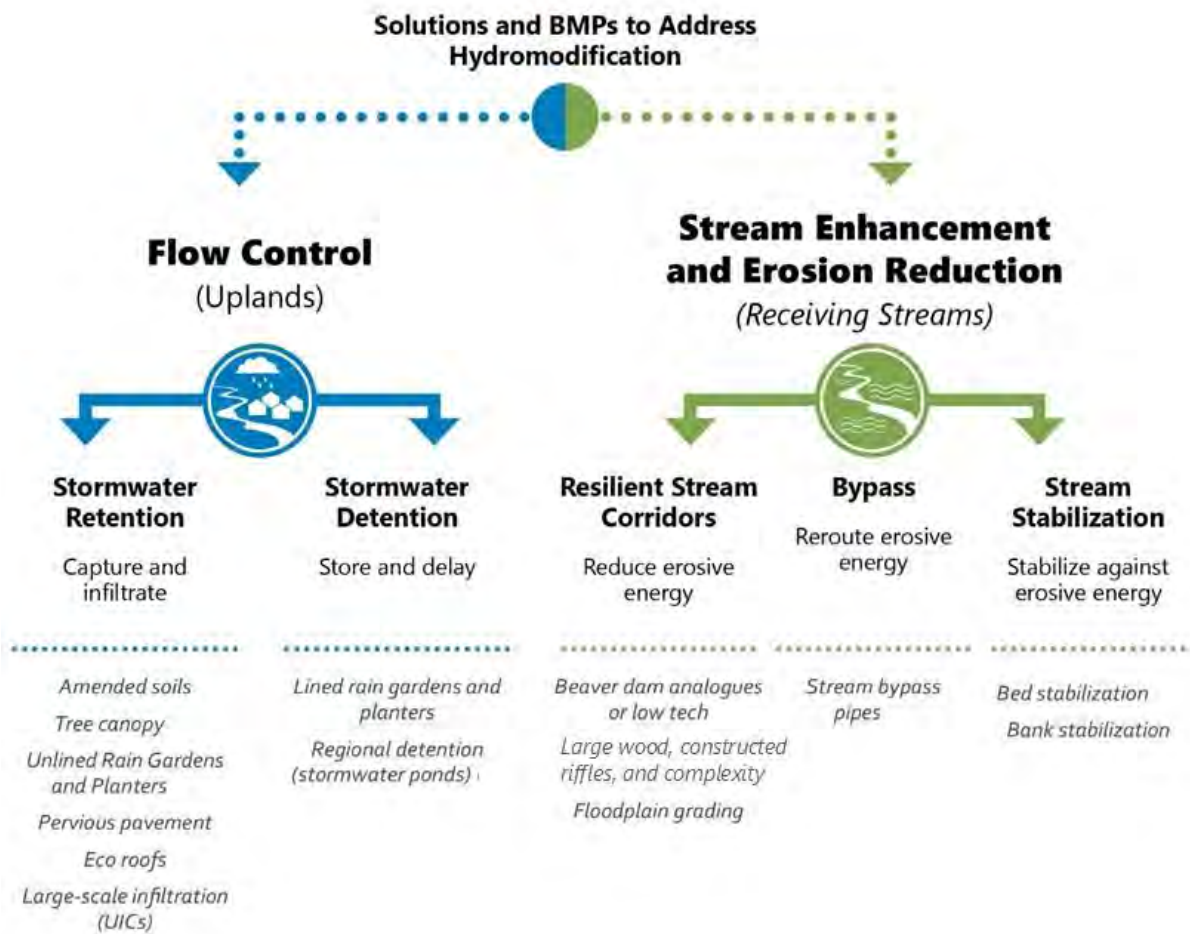
Figure 25: Classification of solutions and BMPs commonly used to address hydromodification and its impacts.

To address these challenges, the following presents a variety of strategies aimed at improving stream conditions. Recommendations are provided for both the Co-Permittees and private landowners, recognizing that effective watershed management depends on collaboration across public and private sectors. As previously discussed, understanding and addressing the impacts of hydromodification is a critical component of watershed management for urban streams. There are different approaches, or best management practices (BMPs) to hydromodification solutions, with upland flow control and stream enhancement being the two fundamental categories. Each of these has multiple subcategories that further define the possible goals and solutions within a hydromodification strategy (Figure 25). An integrated strategy will utilize multiple of these solutions depending on local and system scale needs.

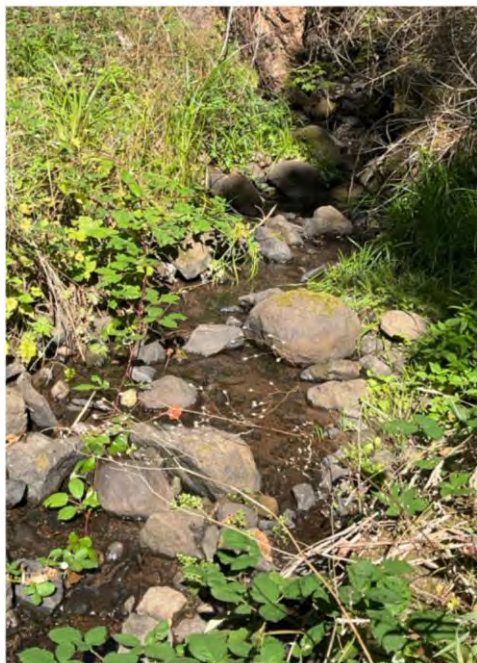
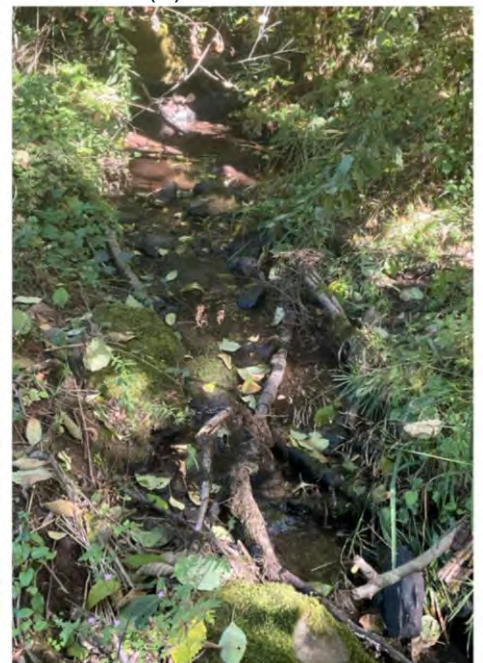
Athey Creek flows northward from steep bluffs into the Tualatin River. Its channel substrate varies between bedrock, gravel, and fines, and it primarily flows through rural properties outside the urban growth boundary, with minimal risk of future development. The watershed is approximately 99.2% private and 0.8% public land.

The creek has good canopy cover, but the riparian zone is largely dominated by invasive vegetation. Trend analysis shows slight improvement in both macroinvertebrate health and degree of floodplain connectivity.

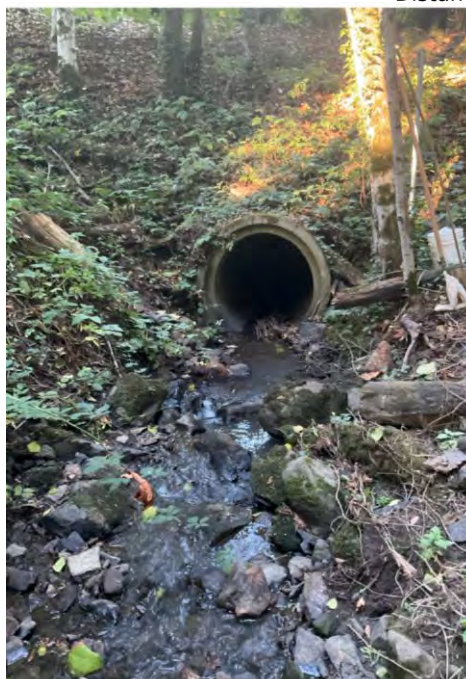
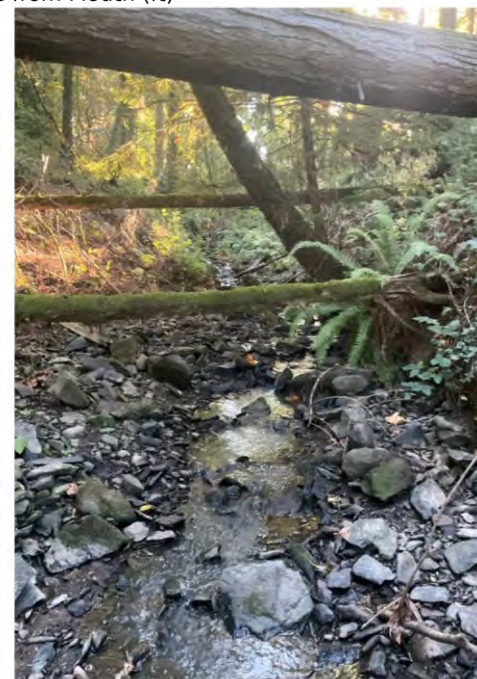
Ball Creek

Canopy cover is relatively high, particularly in the lower watershed. Only one site was visited on the creek, but it exhibited confinement and moderate invasive vegetation.

The trends analysis comparing 2018 and 2024 data found that macroinvertebrate health has remained unchanged between sampling years.

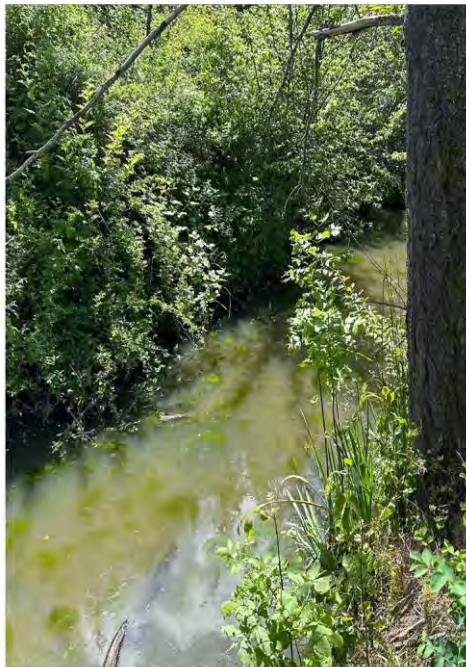
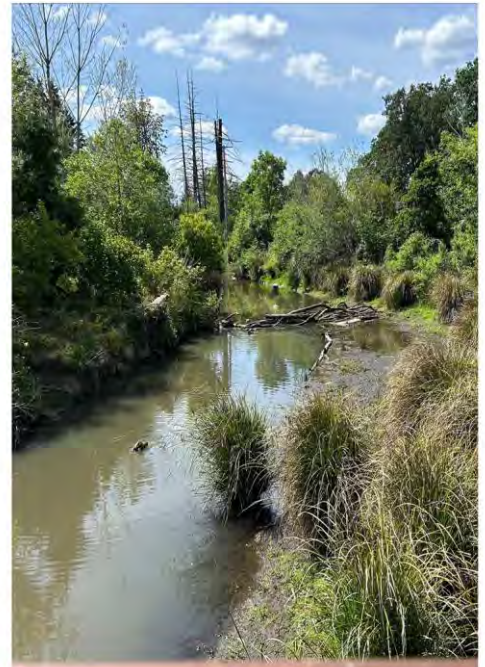
Boardman Creek

Canopy cover throughout the watershed is relatively low, but the two sites that were visited showed healthy riparian corridors with low invasives presence. Water quality was not measured in this creek.

The trends analysis comparing 2018 and 2024 data found that macroinvertebrate health decreased slightly at one site (BO10) and increased at the other (BO20).

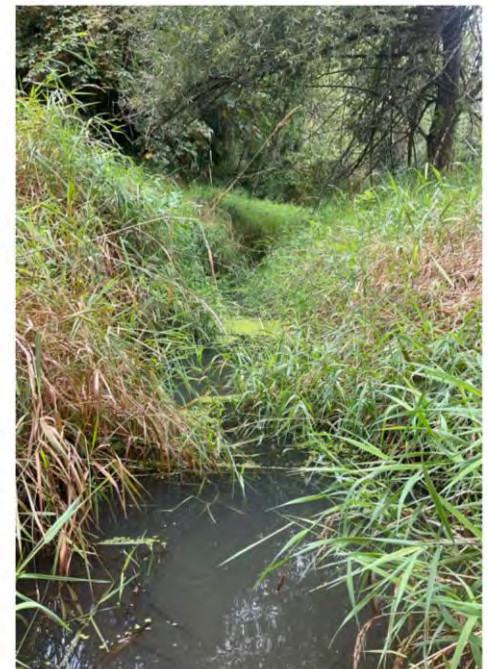
Boeckman Creek is a moderately-low sloping, mostly fine-bedded tributary of the Willamette River. Much of the creek flows through the Boeckman Creek Natural Area.

Although the canopy coverage in the watershed is relatively low, the overall floodplain connectivity and riparian health are higher due to the creek's protection in the natural area. Water quality was not measured in this creek.

The trends analysis comparing 2018 and 2024 data found that macroinvertebrate health varied between sites, with the community at BK10 exhibiting no change and community health increasing at BK20 and BK30.

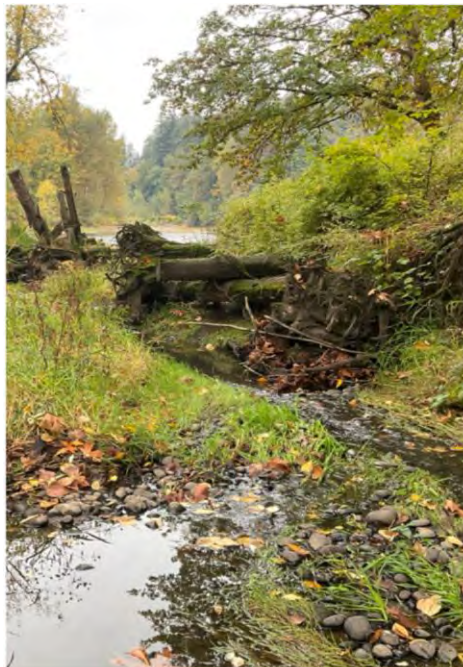
Carli Creek

The creek exhibits moderate floodplain connectivity partly due to recent restoration projects. The gravel-bedded creek exhibited some complexity with large wood but also had prevalent invasive vegetation.

The trends analysis showed no change in floodplain connectivity, but the macroinvertebrate health has improved since 2021.

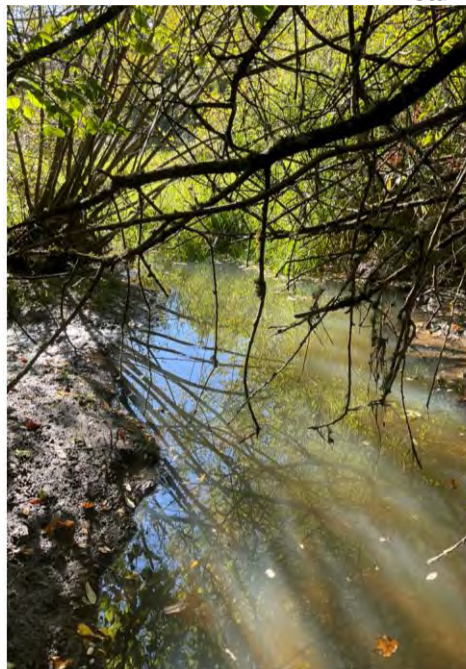
The creek is heavily confined and exhibits low floodplain connectivity. The site visited at Carter Creek showed signs of beaver activity and exhibited low dissolved oxygen and high conductivity.

The trends analysis found that macroinvertebrate health has decreased since 2021.

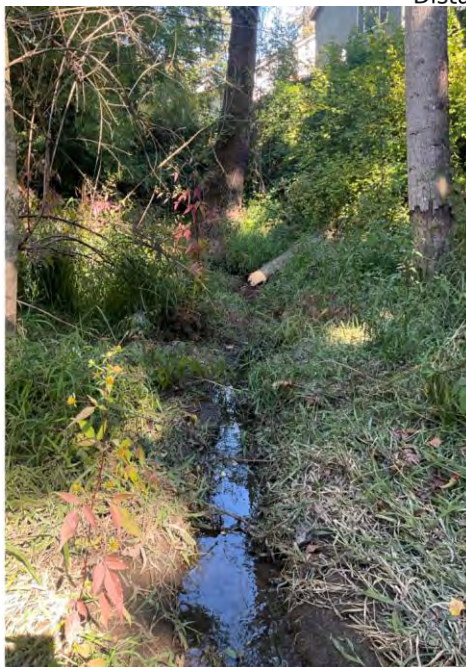
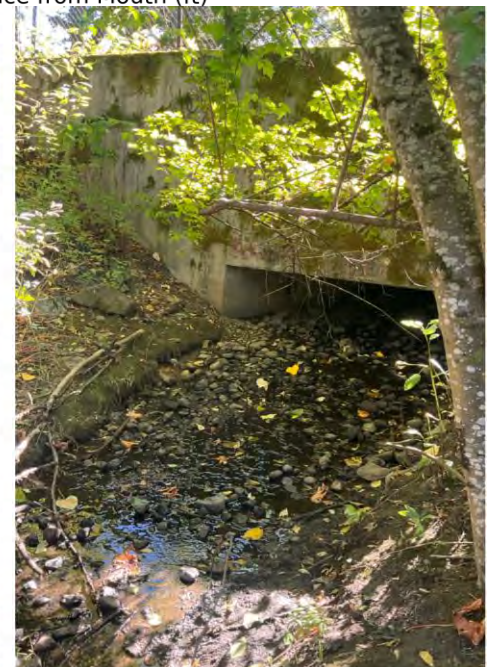
Cedar Creek

Land use impacts are obvious throughout the watershed as many sections of the creek have been straightened, pass through infrastructure, and/or are piped underground.

Trends analysis reveal decreasing macroinvertebrate health and decreasing floodplain connectivity since 2021.

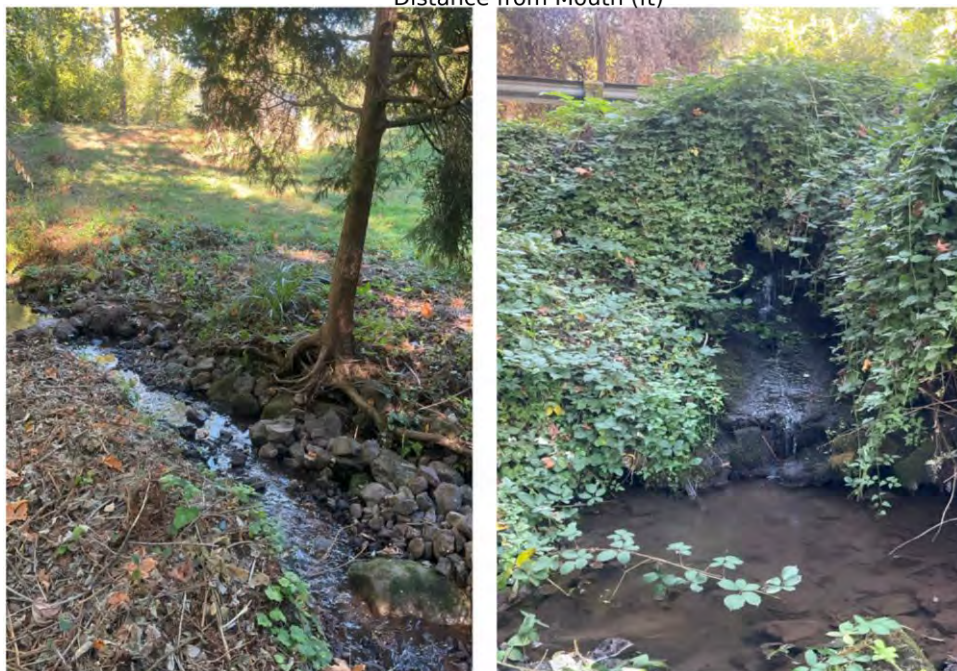
Coffee Creek

The creek is confined and exhibits limited floodplain connectivity. At the site visited on Coffee Creek, the riparian corridor was dominated by blackberry and non-native grasses, including lawn species. The site also exhibited low specific conductivity.

The trends analysis comparing 2018 and 2024 data found that macroinvertebrate health remained unchanged between sampling years.

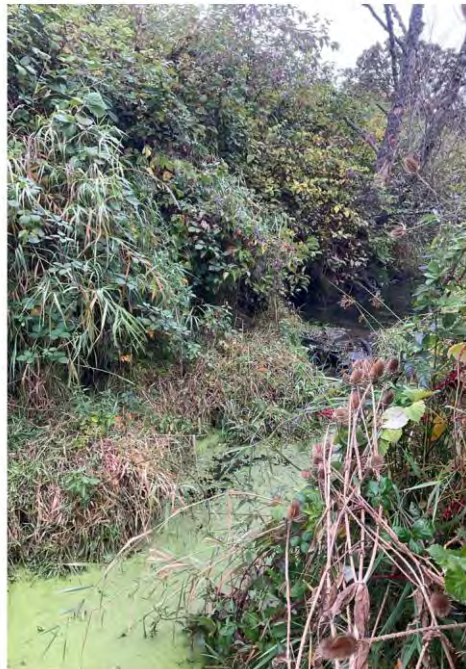
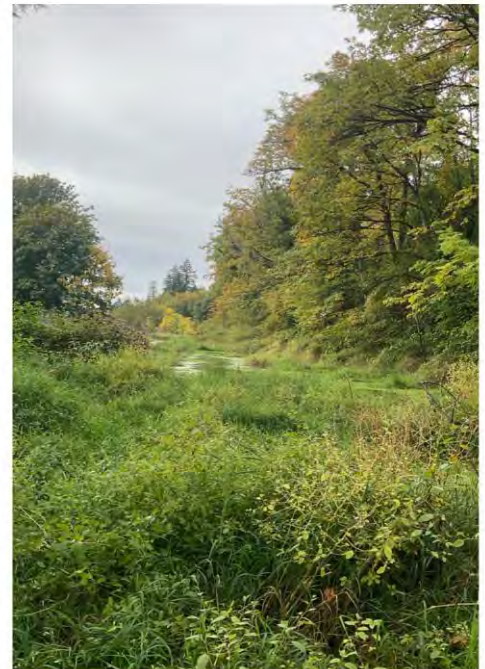
The downstream portion of the creek is low-gradient and appears backwatered, while further upstream the creek is narrowly confined, straightened, and routed through pipes. Water quality at Cow Creek is poor.

The trends analysis found that both macroinvertebrate health and degree of floodplain connectivity have increased since 2021.

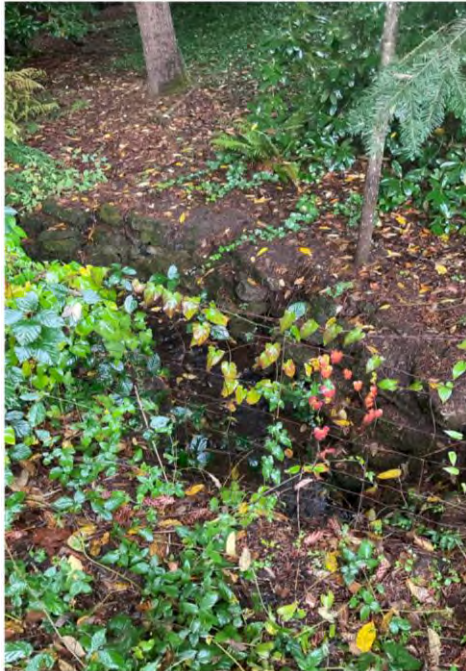
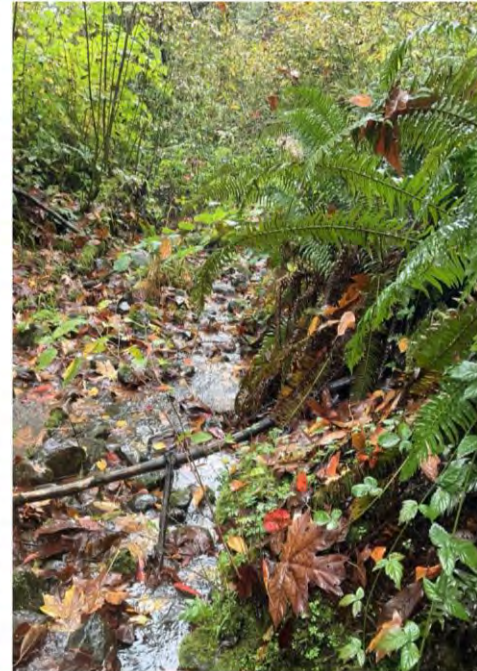
Fields Creek is gravel-dominated and flows northeast off steep bluffs into the Tualatin River. Development pressure and impervious area are both low. The watershed is approximately 97% private and 3% public land.

Fields Creek has very high canopy cover and supports only a moderate presence of invasive vegetation. Much of the creek flows through residential properties and is generally incised.

The trends analysis found that degree of floodplain connectivity has significantly decreased since 2021.

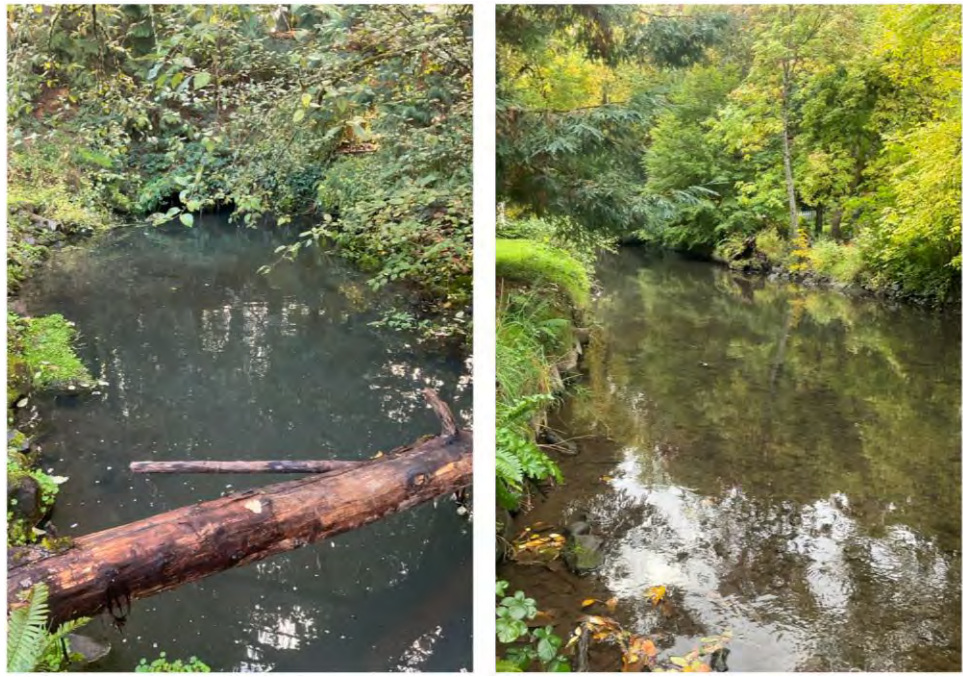
Kellogg Creek is largely channelized, with many sections armored by riprap. Invasive vegetation is present but generally less abundant than in other nearby creeks. The northern tributary shown in the map is Mt. Scott Creek.

Trends analyses show that macroinvertebrate health has decreased since 2021, but floodplain connectivity has increased.

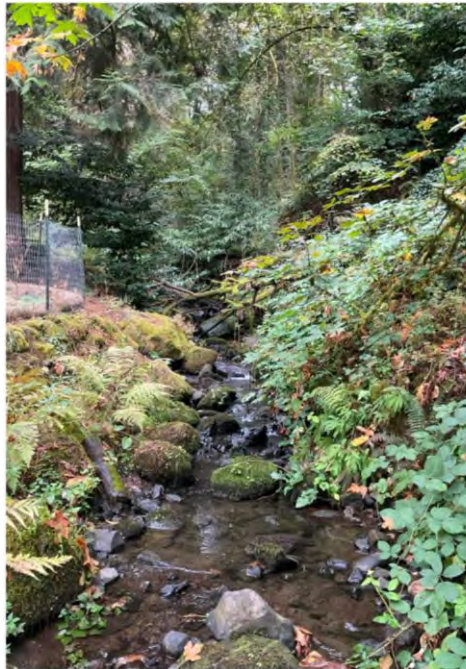
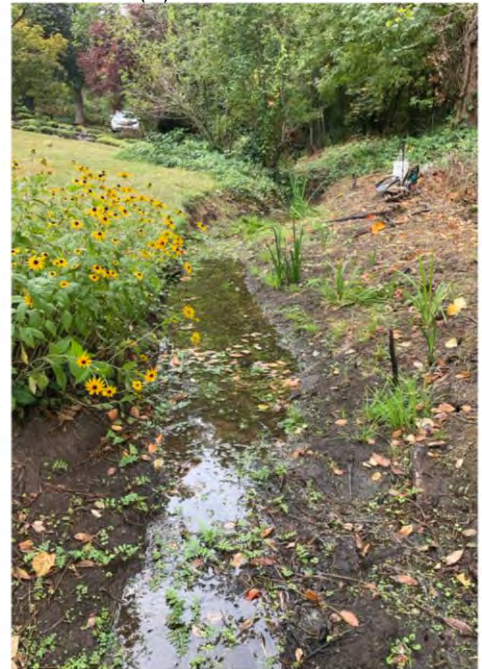
Lost Dog Creek is predominantly channelized and shows signs of widespread bank erosion. Canopy cover is moderate, but invasive species are prevalent throughout the corridor. Several of the sites visited along the creek also had exposed stormwater infrastructure.

Trend analysis indicates a decline in macroinvertebrate health since 2021.

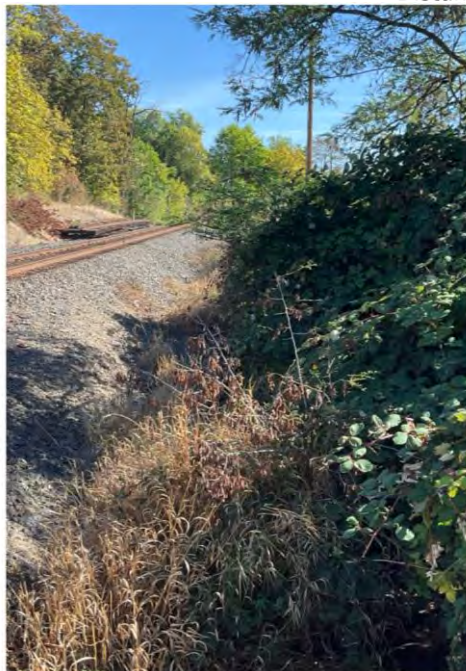
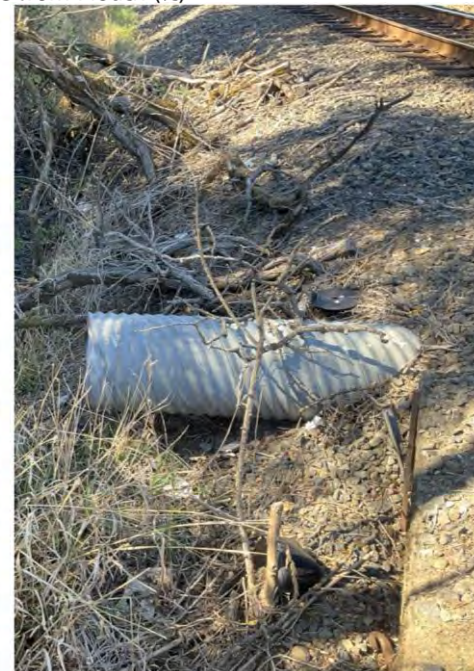
Minthorn Creek flows east into Mt Scott Creek through a predominately industrial area. The watershed has moderate impervious coverage and is approximately 96% private and 4% public land.

The creek exhibits very limited floodplain connectivity and is heavily impacted by surrounding infrastructure. Canopy cover is minimal. The site visited in 2024, located adjacent to railroad tracks, showed severe ecological degradation and lacked active surface flow, preventing the collection of macroinvertebrate samples and water quality measurements.

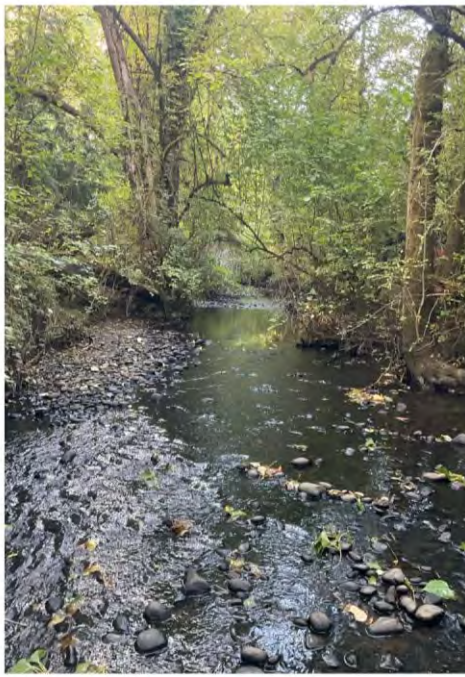
Mt. Scott Creek flows west to its confluence with Kellogg Creek and ultimately into the Willamette River. It passes through both parks and residential areas, with the watershed comprising approximately 86% private and 14% public land.

Mt. Scott Creek displays a range of physical conditions, with downstream sections characterized by gentle slopes and broader, more connected floodplains, transitioning to steeper, incised reaches in the headwaters.

Trend analysis shows macroinvertebrate health has improved at two of three monitored sites, with no notable change in floodplain connectivity since 2021.

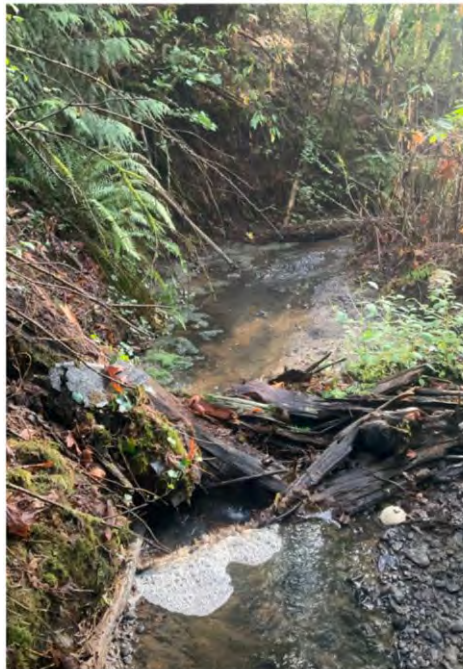
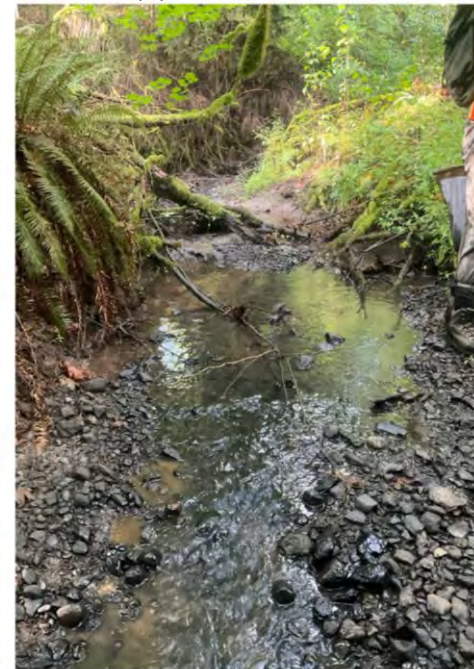
Nettle Creek

Canopy cover is high throughout the watershed. The site visited in 2024 showed moderate invasive species presence, signs of historic beaver activity, and a culvert contributing to backwatered flow conditions.

Trend analysis indicates a decline in macroinvertebrate health since 2021.

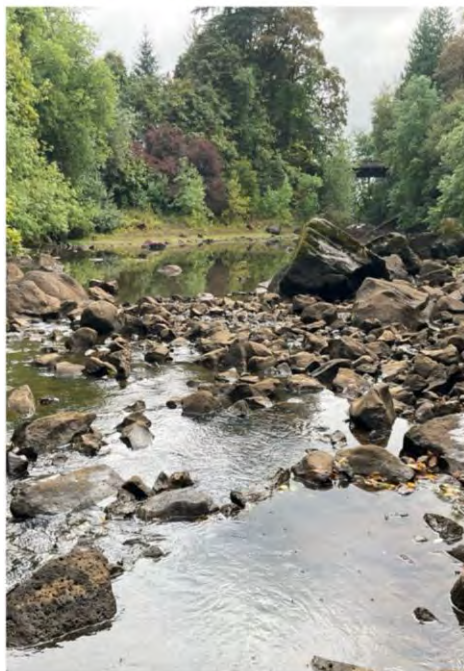
Oswego Creek

The site visited in 2024 was experiencing backwatered conditions from the Willamette River and there was a decommissioned hydropower structure towards the upstream limits of the reach. The site exhibited moderate floodplain connectivity with minimal invasive vegetation present.

Trend analysis indicates a decline in macroinvertebrate health since 2021.

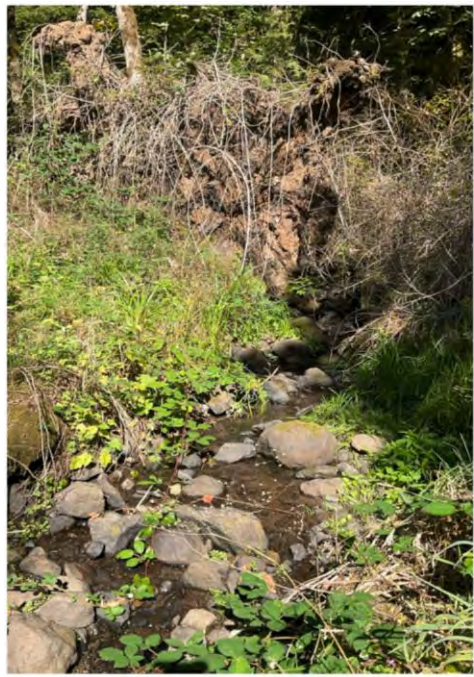
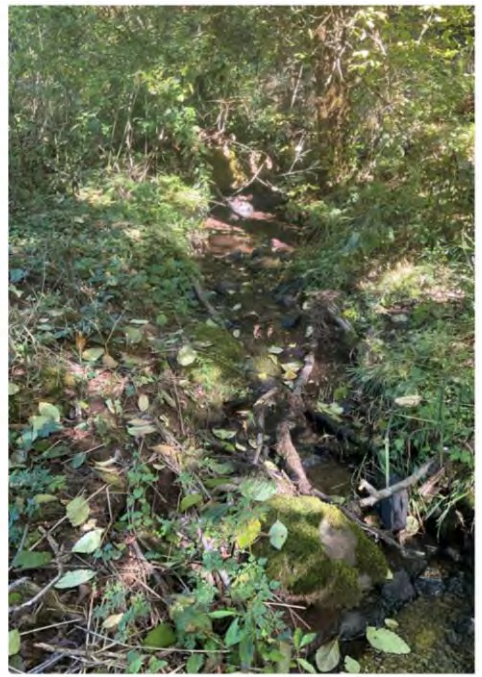
Much of Pecan Creek exhibits confined conditions. Invasive vegetation in the watershed is low and there appears to be adequate recruitment of small and large wood.

Trend analysis indicates an increase in both macroinvertebrate health and floodplain connectivity since 2021.

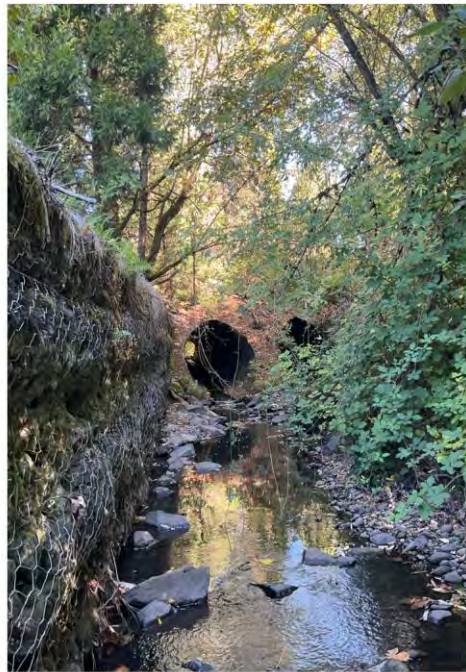
Phillips Creek

The creek is very straightened and wholly entrenched along its entire length. There is a lot of rip-rap and retaining walls present and canopy cover is very low.

Trend analysis indicates no change in macroinvertebrate health and a decrease in floodplain connectivity since 2021.

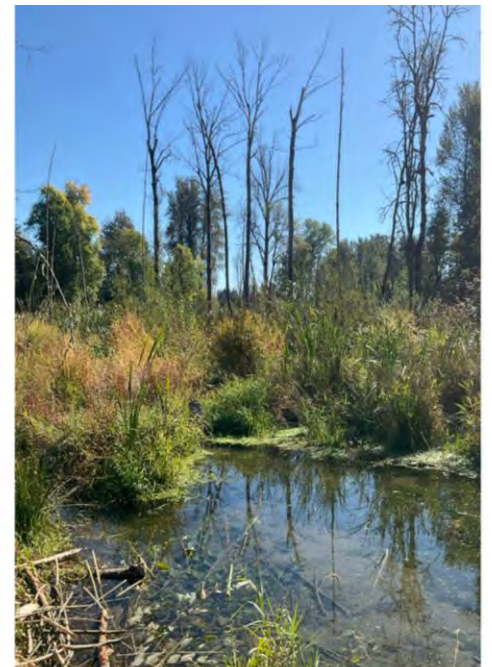
Richardson Creek

The creek has a consistent slope as it has cut a deep canyon through gravel rich soils. Dissolved oxygen levels are impacting water quality along parts of the creek, but macroinvertebrate health remains high.

Trend analysis indicates no change in macroinvertebrate health and a decrease in floodplain connectivity since 2021.

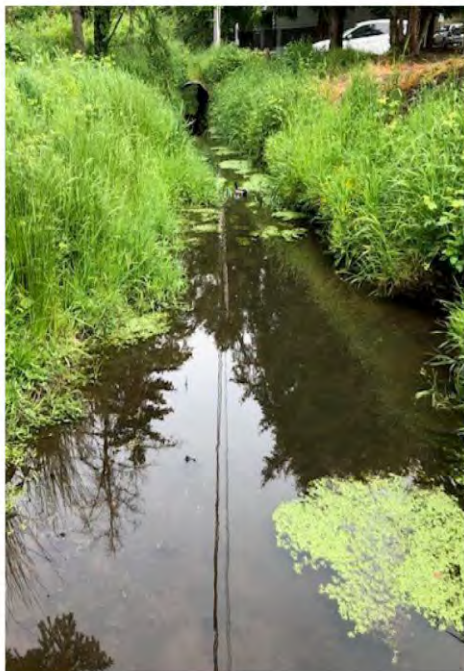
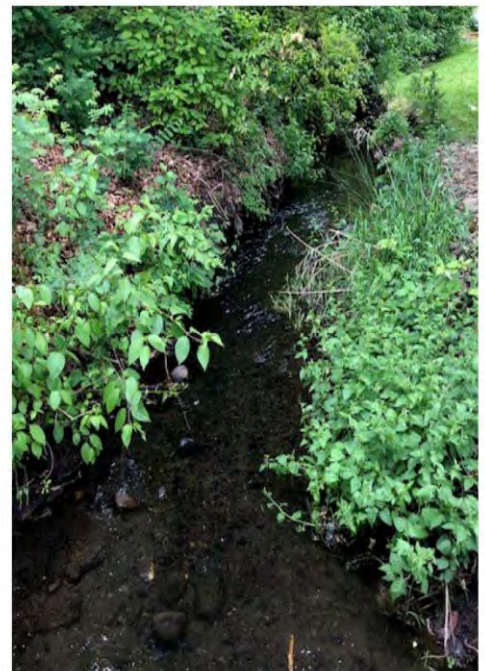
Rinearson Creek flows west into the Willamette River. The downstream portion of the creek is backwatered from the Willamette River and relic water control structures. The watershed has high impervious area and is approximately 86% private and 14% public land.

The site visited on Rinearson Creek in 2024 was incised and confined on either side by riprap. Evidence of bank erosion was observed, along with a moderate presence of invasive vegetation.

The trends analysis comparing 2018 and 2024 data found that macroinvertebrate health increased slightly between sampling years.

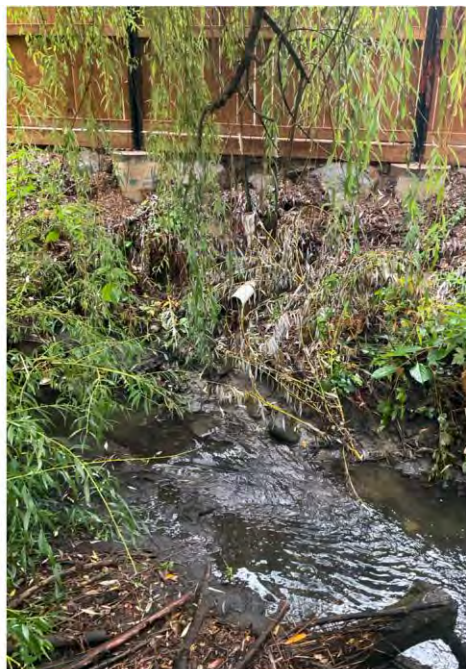
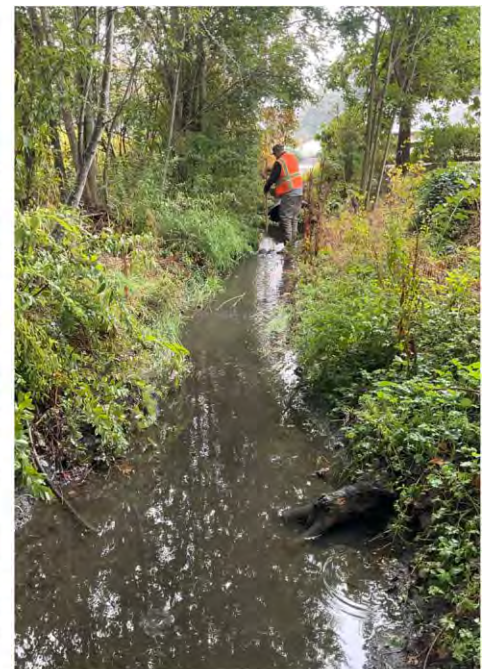
The site visited on River Forest Creek in 2024 was bounded on either end by culverts. The creek was straightened and confined by rip rap on the left bank, resulting in a low degree of floodplain connectivity.

The trends analysis comparing 2018 and 2024 data found that macroinvertebrate health decreased slightly between sampling years.
