CLACKAMAS
WATER
ENVIRONMENT
SERVICES

BENTHIC MACROINVERTEBRATE & GEOMORPHOLOGICAL MONITORING REPORT

2024 MONITORING RESULTS

CASM ENVIRONMENTAL, LLC

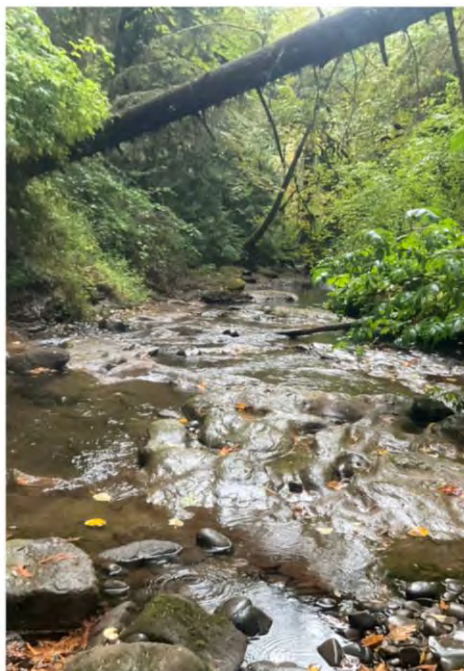
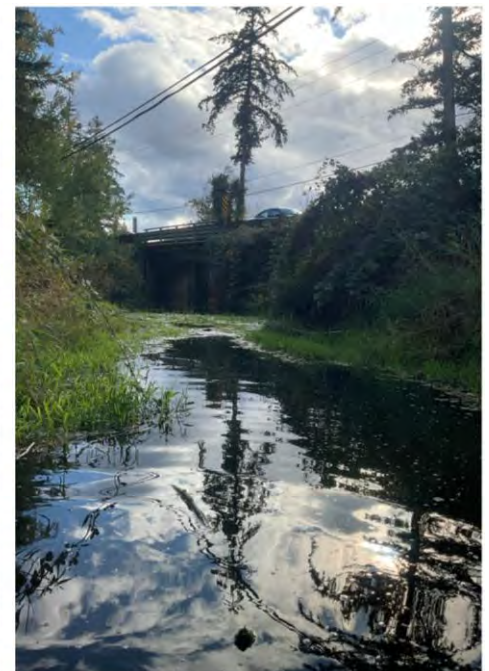
Although Rock Creek includes some low-gradient sections with adequate floodplain access, many areas are incised with some even down to bedrock. Infrastructure was observed at all visited sites, and one site showed evidence of beaver activity.

Trend analysis indicates that 2 of the 3 sites have shown a decline in macroinvertebrate health, but floodplain connectivity has improved since 2021.

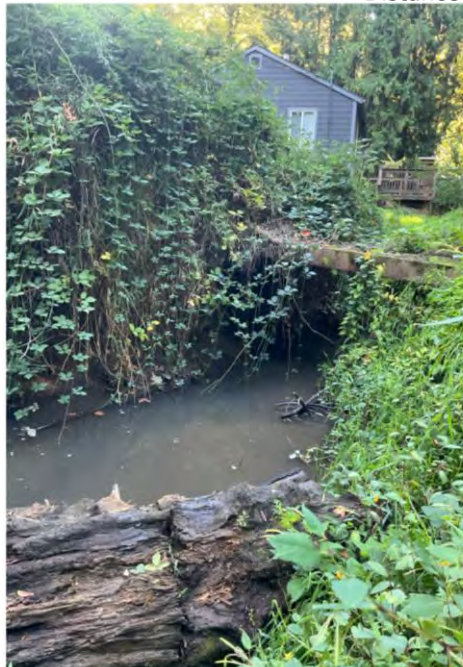
Saum Creek

Overall, Saum creek is entrenched and has moderate floodplain connectivity. There are, however, some low gradient portions along I-205 that are less confined.

Trend analysis indicates that macroinvertebrate health has increased since 2021, but floodplain connectivity has slightly decreased.

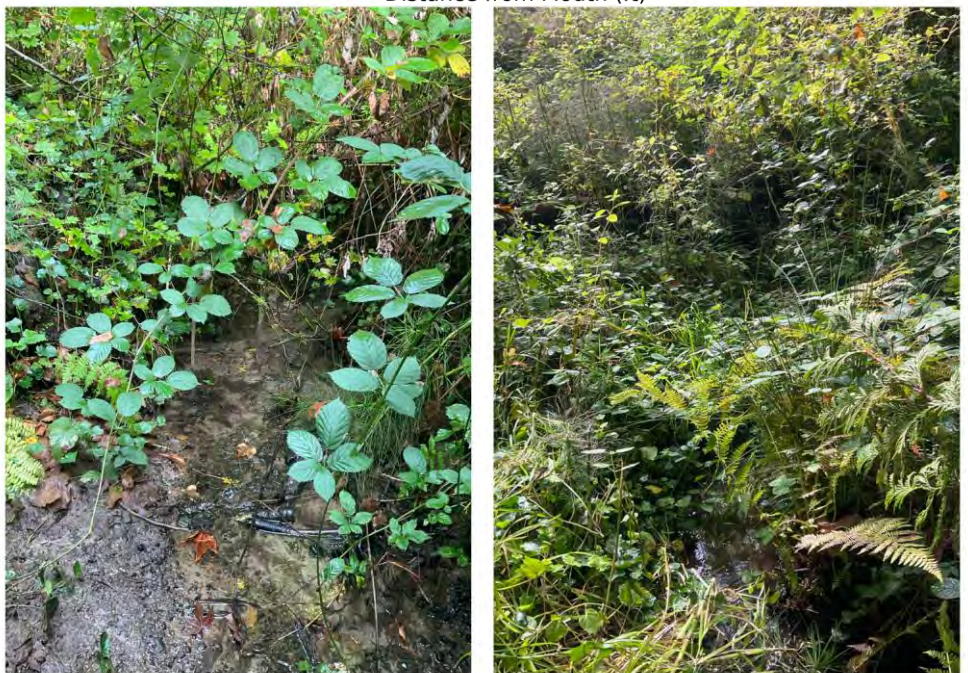
Shipley Creek

The creek is small and overrun with invasive riparian vegetation, leading to incision and floodplain disconnection. The creek has relatively low flow, with some portions running dry and just holding stagnant water, possibly leading to some of the water quality concerns observed.

Trend analysis indicates that macroinvertebrate health has decreased since 2021, but floodplain connectivity has slightly increased.

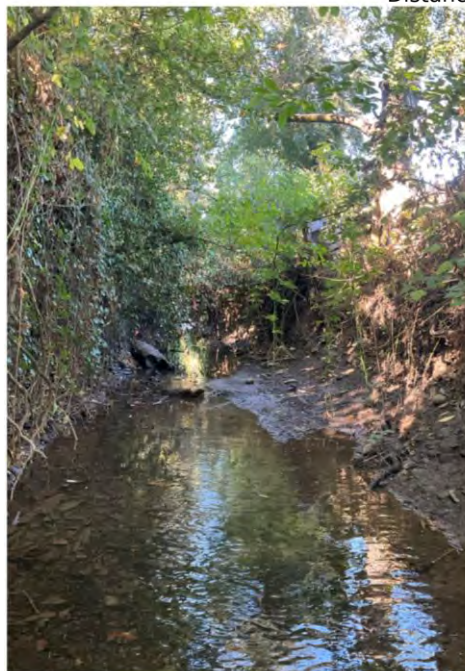
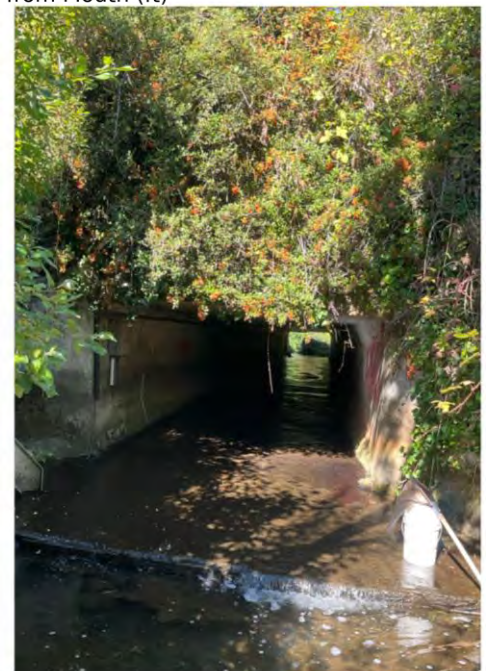
Sieben Creek

Most of the creek is entrenched and no longer connected to its floodplain. Canopy cover is moderate, but invasive vegetation was present throughout. There are numerous areas of stagnant water and other areas where the creek acts more as a drainage ditch.

Trend analysis indicates that macroinvertebrate health has decreased since 2021, but floodplain connectivity has slightly increased.

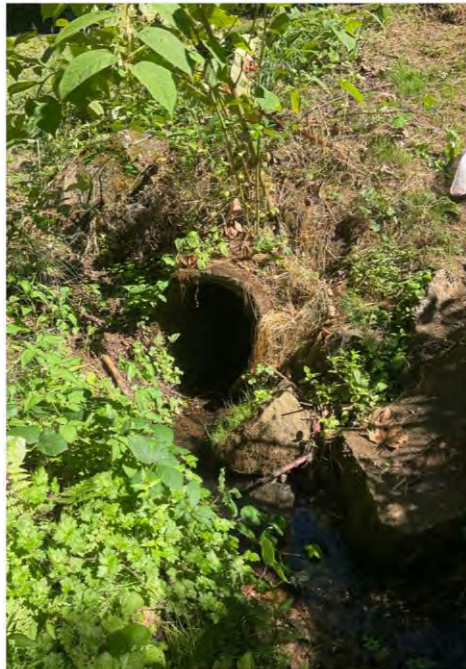
Singer Creek flows north into the Willamette River. Part of the creek flows through Singer Creek Park. The watershed has moderate impervious area and is approximately 86% private and 14% public land.

The site visited along Singer Creek in 2024 was dominated by invasive vegetation, particularly knotweed. There was a culvert present, as well as an area where flow went subsurface.

The trends analysis comparing 2018 and 2024 data found that macroinvertebrate health decreased between sampling years.

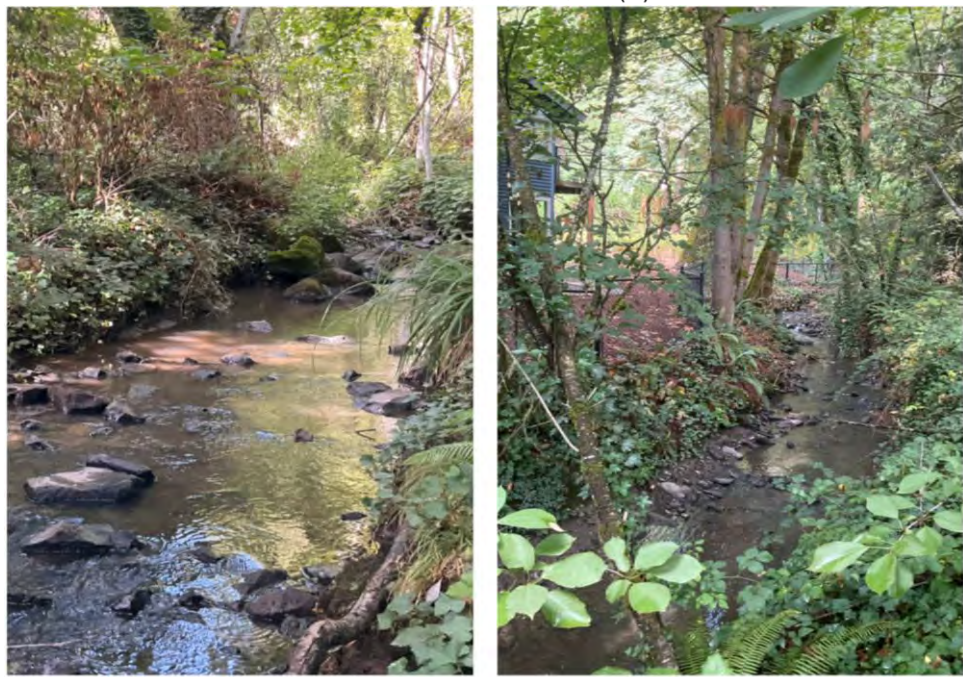
Springbrook Creek flows south into Lake Oswego. Much of the creek flows through parks and natural areas. The watershed has moderate impervious area and is approximately 86% private and 14% public land.

Some portions of Springbrook Creek exhibit higher floodplain connectivity, particularly those portions in natural areas further away from infrastructure.

The trends analysis found that macroinvertebrate health increased at one site and decreased at the other as compared to 2021.

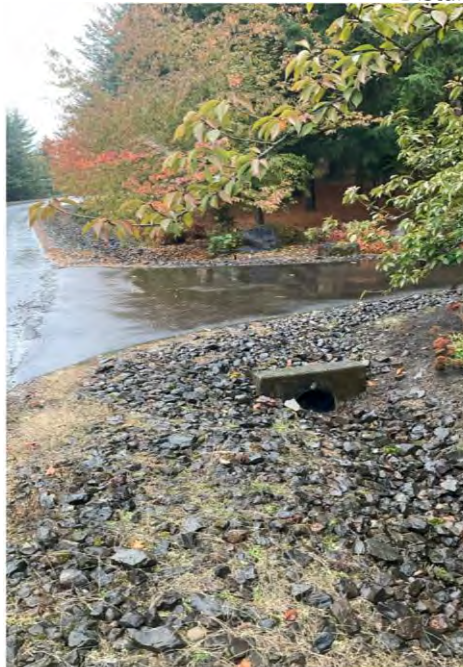
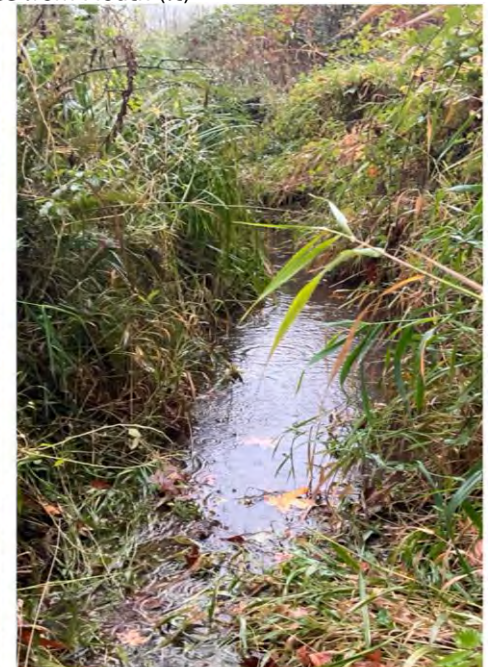
The downstream portions of Tate Creek are backwatered by the Tualatin River, but further upstream in the watershed the creek steepens and has eroded down to bedrock in some locations. The watershed generally has good canopy cover.

Trend analysis indicates that macroinvertebrate health has decreased since 2021, but floodplain connectivity has remained unchanged.

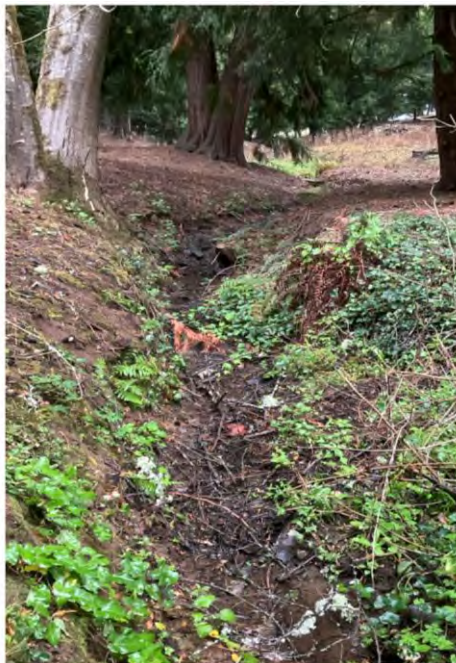
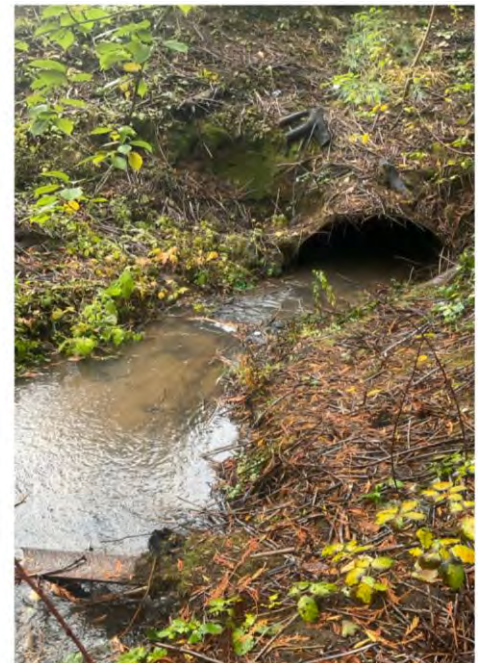
Tributary 2 transitions from a low-gradient, channelized reach downstream to a steep, incised reach upstream. The watershed experiences low development pressure and maintains high canopy cover.

Trend analysis indicates that both macroinvertebrate health and floodplain connectivity have increased since 2021.

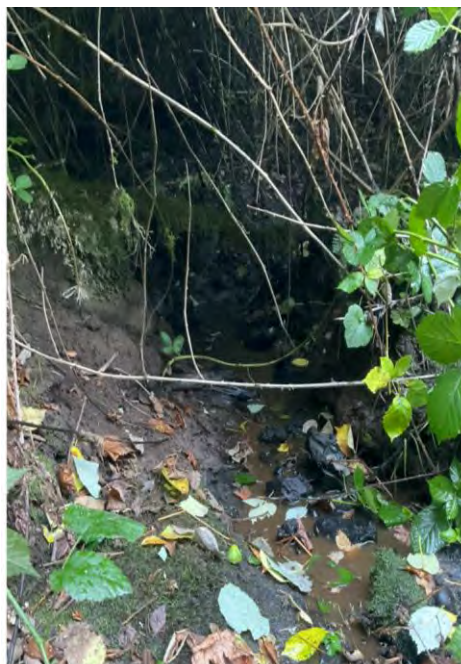
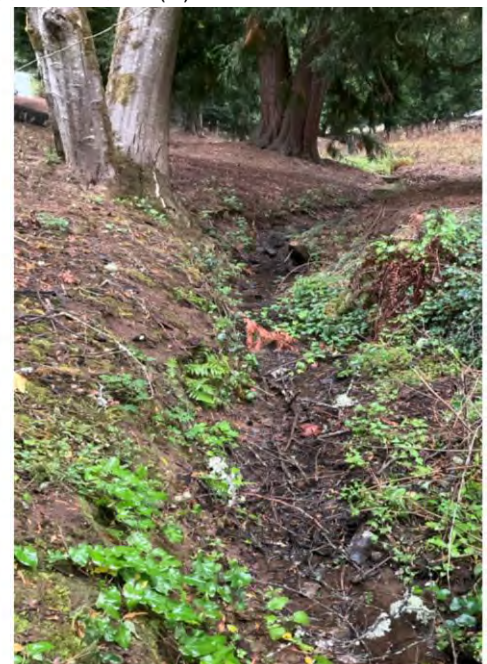
Tributary 4

Both sites visited in 2024 exhibited signs of degradation associated with adjacent infrastructure, and in some sections, the creek functioned more like a stormwater ditch. Invasive species were prevalent at both locations. Despite these impacts, the watershed overall experiences low development pressure.

Trend analysis indicates that macroinvertebrate health has improved, and floodplain connectivity has remained unchanged since 2021.

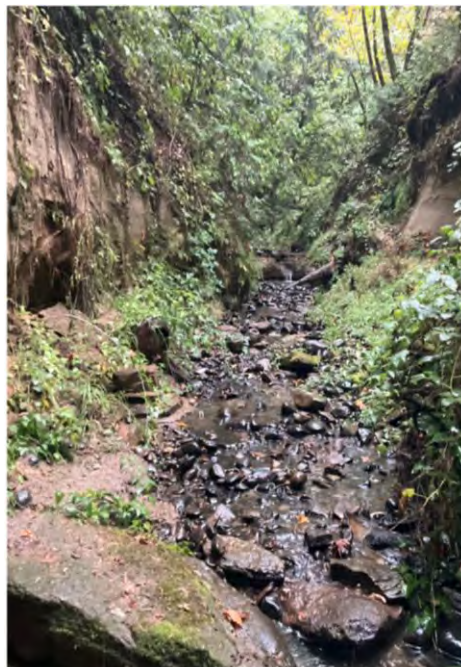
Trillium Creek (WES)

The upstream portion of the creek is steep and bounded by overhanging canyon walls, resulting in limited floodplain connectivity. Although canopy cover is generally low throughout the watershed, two of the sites visited supported healthy riparian vegetation.

Trend analysis indicates that both macroinvertebrate health and floodplain connectivity have decreased since 2021.

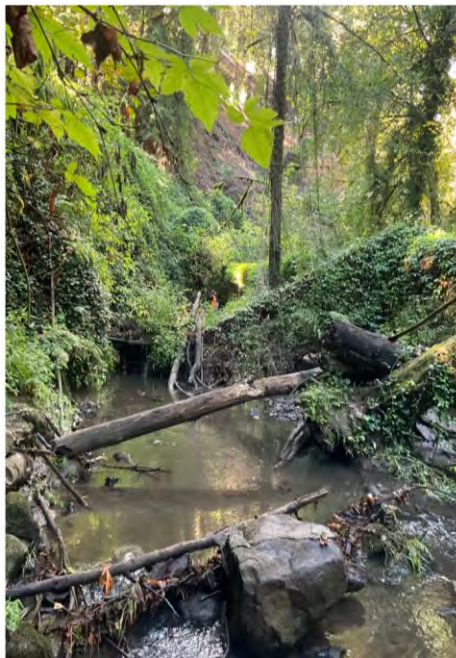
Tryon Creek

The site visited in 2024 showed moderate floodplain connectivity and habitat complexity from downed trees and boulders in the channel. Due to the state park, the watershed has low development pressure and high canopy coverage.

The trends analysis found that macroinvertebrate health has decreased since 2021.

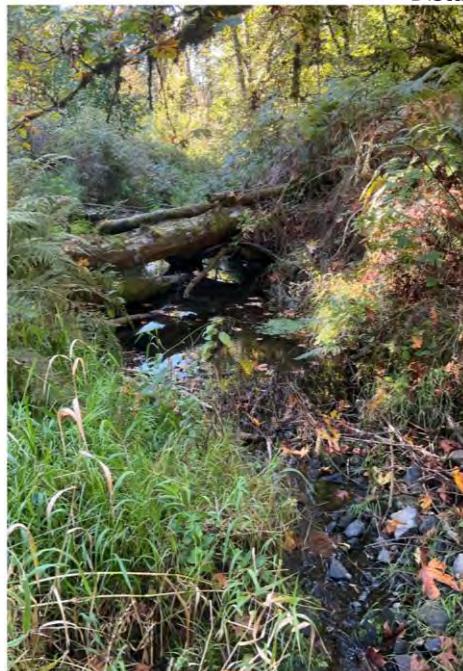
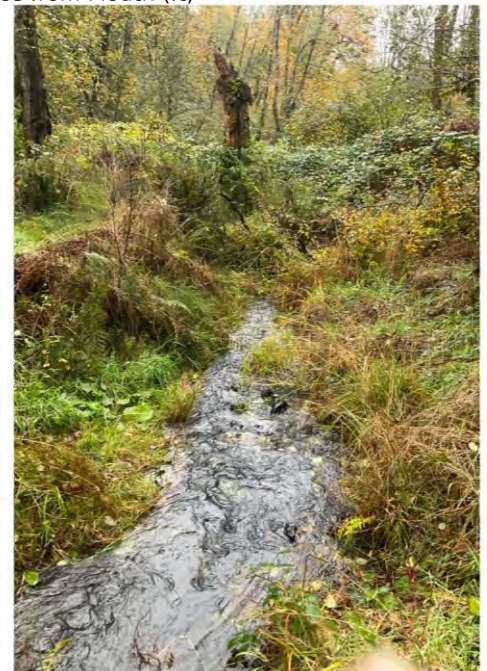
The creek is low gradient near the Tualatin where it experiences backwater conditions and then steepens as it flows through Wilson Creek Natural Area. The creek is well-connected to its floodplain within the Wilson Creek Natural Area.

Trend analysis indicates that both macroinvertebrate health and floodplain connectivity have increased since 2021.
