CLACKAMAS
WATER
ENVIRONMENT
SERVICES

BENTHIC MACROINVERTEBRATE & GEOMORPHOLOGICAL MONITORING REPORT

2024 MONITORING RESULTS

Client: Clackamas Water Environment Services

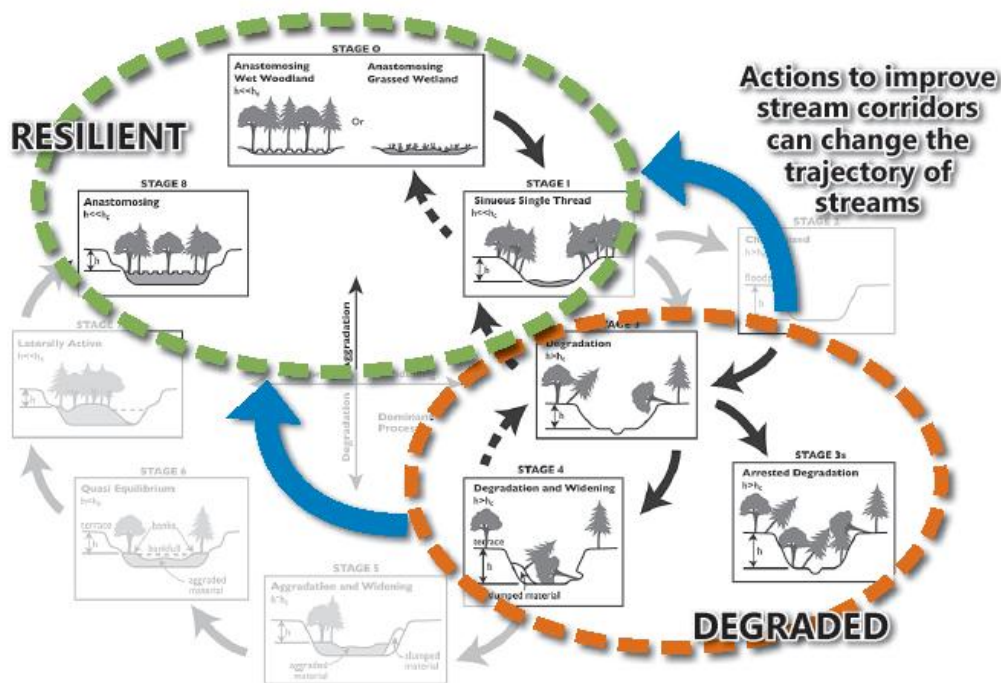
Figure 1: Channel Evolution Model (Cluer and Thorne, 2014) showing recovery pathways associated with stream resiliency.

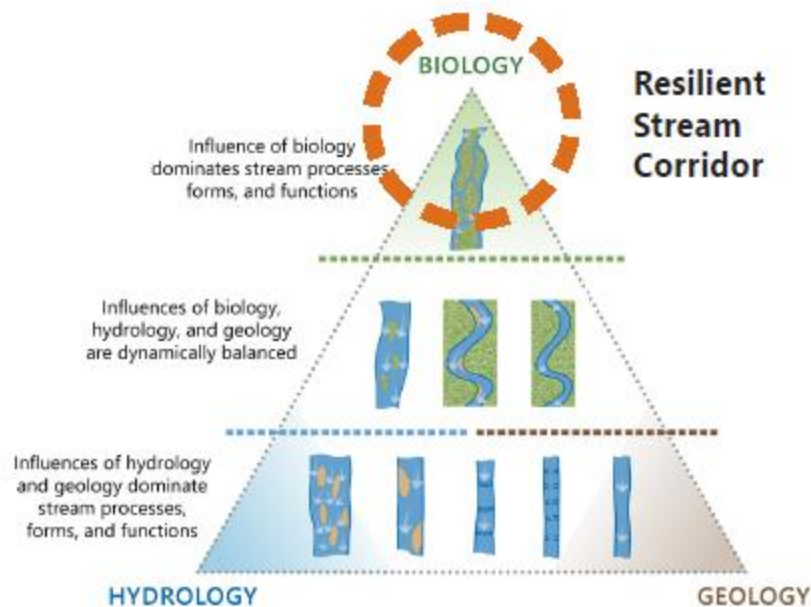
Figure 2: Stream Evolution Triangle (Castro and Thorne, 2019) showing the interplay of geologic, hydrologic, and biological influences on channel-floodplain forms and dominance of biological influences on resilient stream corridors.

Hydromodification impacts more than just channel form, it also degrades aquatic habitat and biological integrity. As shown in Figure 2, stream health is shaped by the dynamic balance between hydrology, geology, and biology. In urban streams, altered flow patterns, simplified channels, and impaired riparian zones reduce habitat complexity and water quality, leading to declines in benthic macroinvertebrate communities.

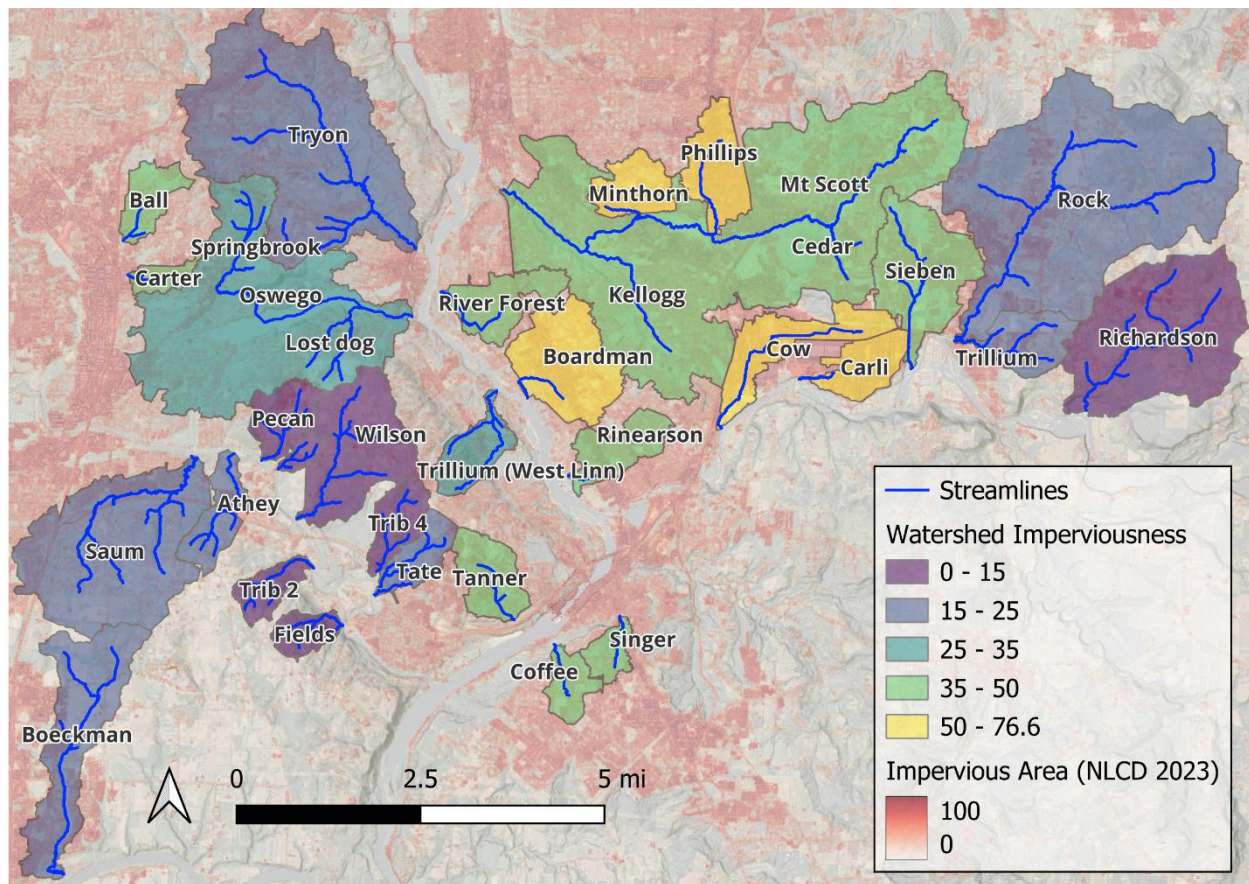
All streams in the study area maintain some level of development. Carli Creek has the highest level of development with 76.5% impervious cover, while Fields Creek has the lowest impervious cover at just under 5%. In general, the east side creeks have experienced more development, particularly along major corridors like SR 99E, SR 224, and 82nd Ave.

Figure 5: 2023 NLCD impervious area across the study area with watershed averages.

Hydromodification impacts, and therefore stream health, are closely linked to impervious surface coverage, making it important to evaluate imperviousness across the study area. The National Land Cover Database (NLCD) was used to estimate impervious cover for the years 1985, 2007, 2014, 2019, and 2023. The 2023 dataset (USGS, 2024) was used to represent existing conditions (Figure 5).

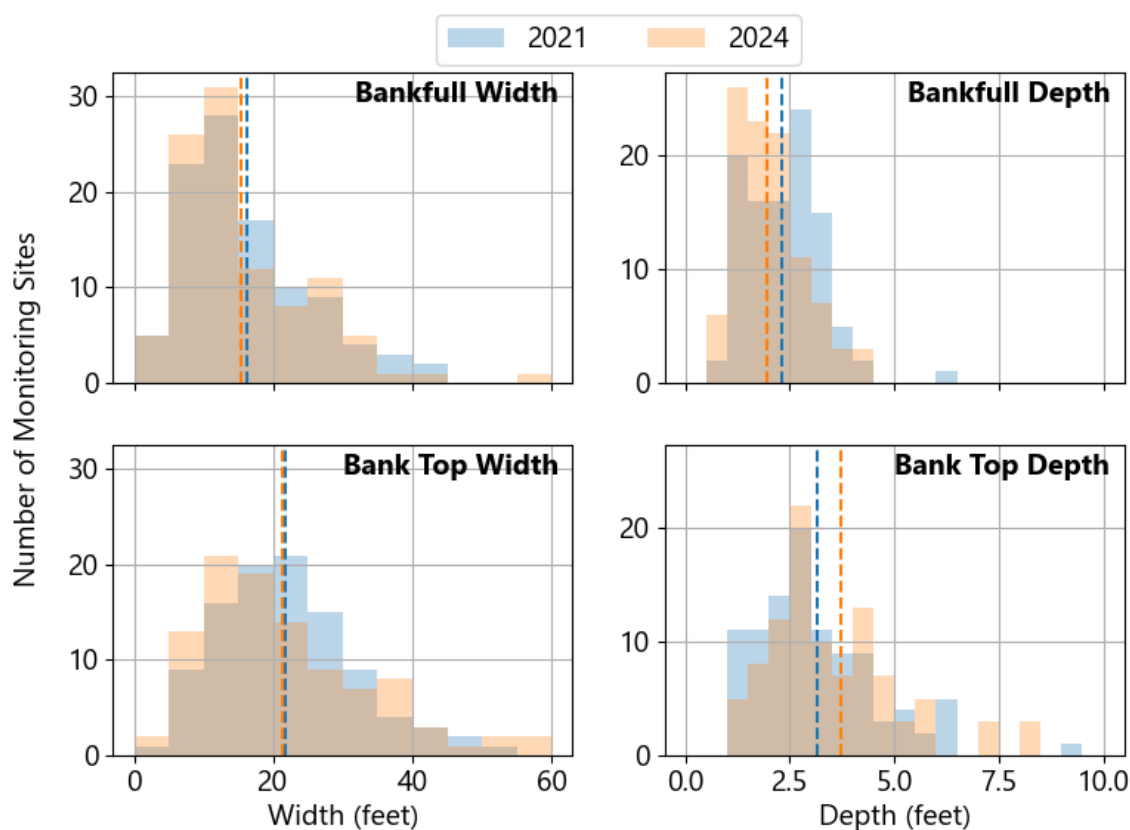
Channel geometry measurements collected in 2021 and 2024 at 110 paired sites were used to compare changes in channel size and shape. Over a three-year period, major shifts in channel form are not typically expected, as geomorphic changes often occur over longer timescales. However, localized factors such as new development or beaver activity can cause abrupt changes in channel geometry. This comparison also serves as a check on potential observer bias in collecting relative measurements, with generally consistent values expected between 2021 and 2024. Figure 6 supports this expectation, showing little to no change in the distribution of observed channel geometry measurements as the changes in average measured value are within the standard deviations of the populations.

Figure 6: Histograms of measured channel geometry variables, compared between 2021 and 2024. Mean values are indicated with dashed lines.

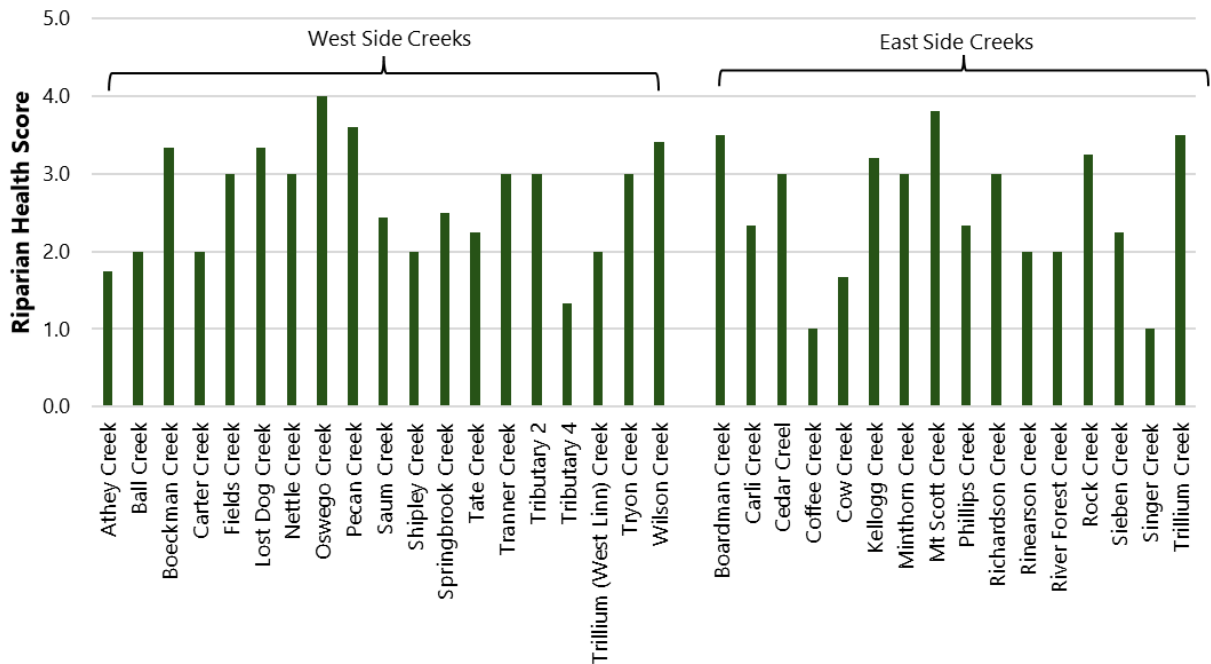
Overall, most creeks fall within the moderate range, scoring between 2.0 and 3.5, indicating fair riparian condition with room for improvement. Oswego Creek, Pecan Creek, Boardman Creek, Mt. Scott Creek, and Trillium (WES) Creek achieved relatively higher scores near or above 3.5, suggesting stronger riparian health. Conversely, some creeks such as Boeckman Creek, Coffee Creek, and Springbrook Creek scored below 2.0, indicating degraded riparian zones and likely limited native vegetation (Figure 9). Although riparian health was documented during the 2021 monitoring effort, differences in observation methods between years prevent direct comparison of scores across the two monitoring periods.

Figure 9: Summary of 2024 riparian health scoring per creek.

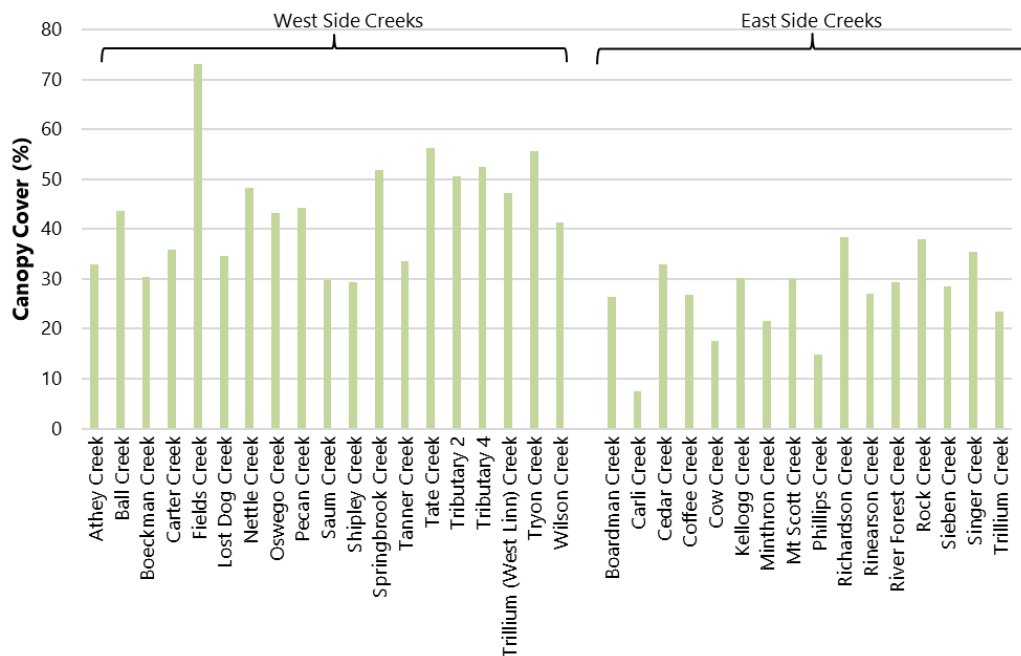
Canopy cover results (Figure 10) show wide variability across sites. Fields Creek had the highest observed canopy cover at over 70 percent, followed by several sites including Tate Creek, Tryon Creek, Tributary 4, and Springbrook Creek with values above 50 percent, suggesting relatively intact riparian vegetation. In contrast, sites on Carli Creek, Phillips Creek, and Cow Creek had canopy cover below 20 percent.

Figure 10: Percent canopy coverage per watershed from the Metro RLIS 2019 canopy raster.

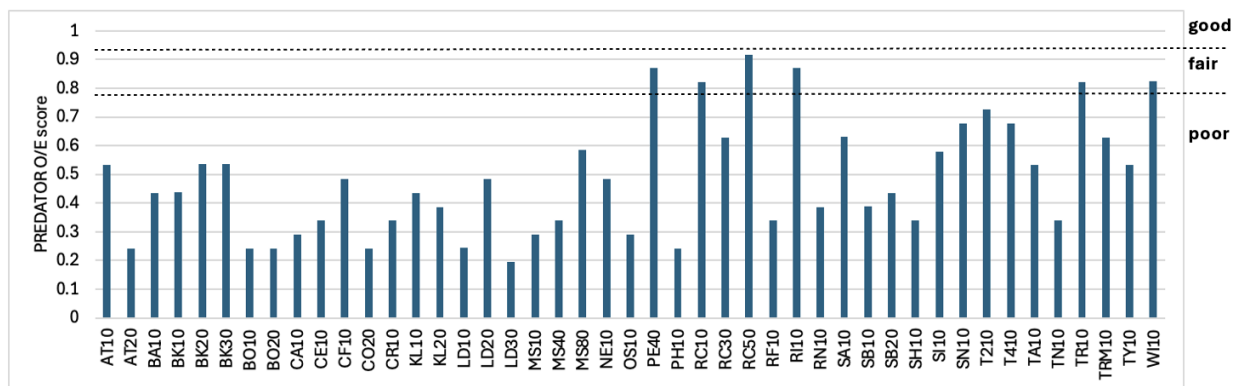
Figure 13: PREDATOR O/E scores. Dashed lines show score ranges corresponding to poor, fair, and good biological conditions.

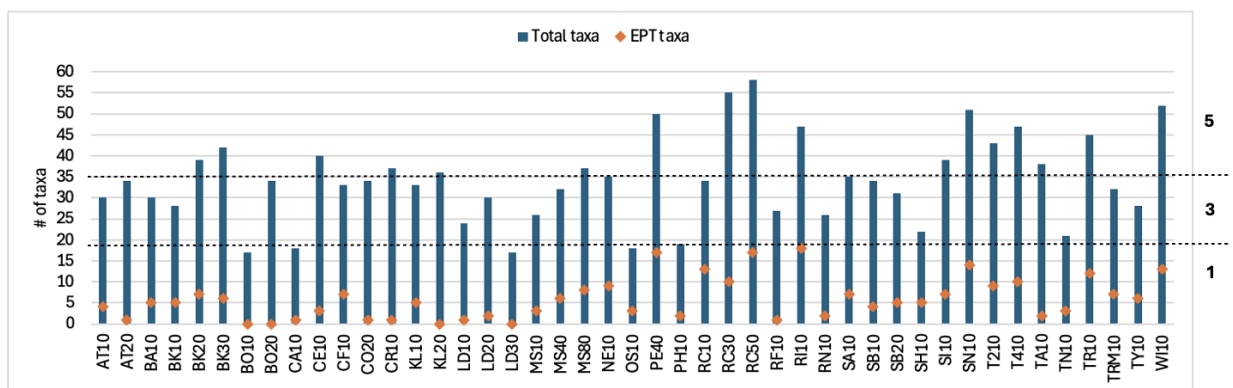
Figure 14: Total sample and EPT (Ephemeroptera [mayfly], Plecoptera [stonefly], Trichoptera [caddisfly]) taxa. Dashed lines show corresponding scaled values for total sample taxa in the M-IBI.

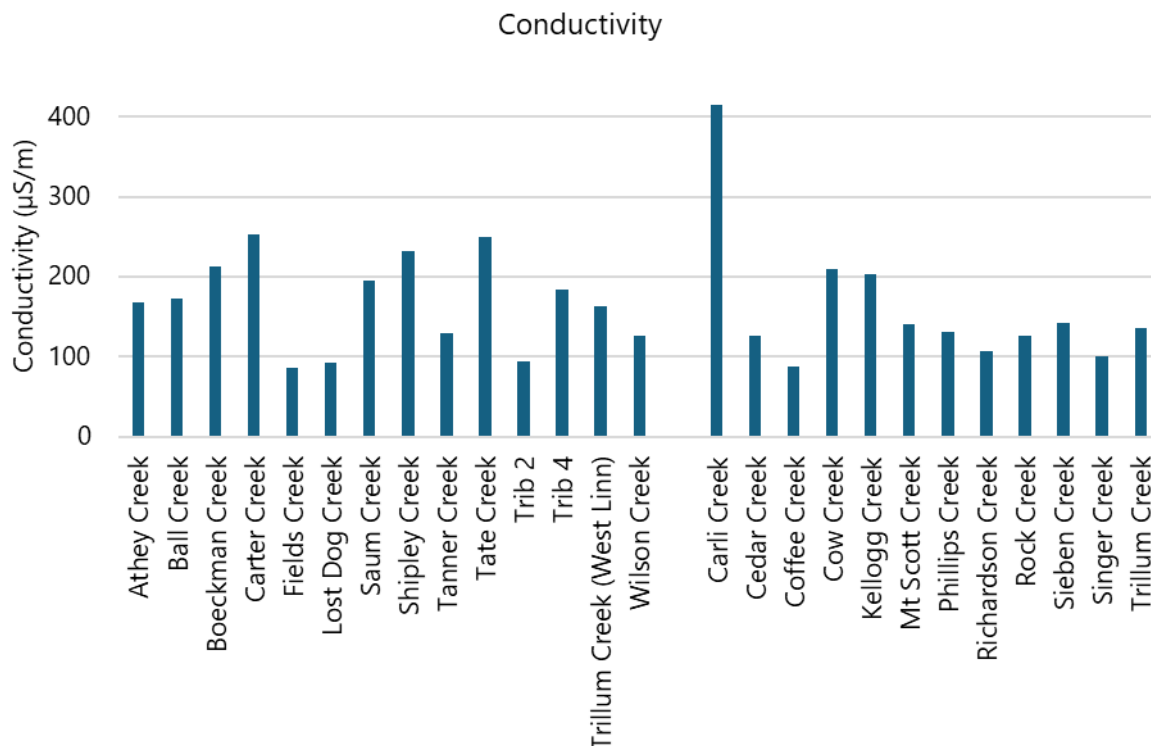
In general, conductivity values between 50 and 150 $\mu\text{S}/\text{cm}$ are typical for streams in minimally impacted watersheds. Values above 150 $\mu\text{S}/\text{cm}$ may indicate underlying geologic conditions or minor human influence, while those exceeding 500 $\mu\text{S}/\text{cm}$ are often associated with more substantial pollution sources. None of the sampled streams exceeded 500 $\mu\text{S}/\text{cm}$, though Carli Creek's measurement suggests some level of anthropogenic impact.

Figure 19: Conductivity results for all water quality documented streams.

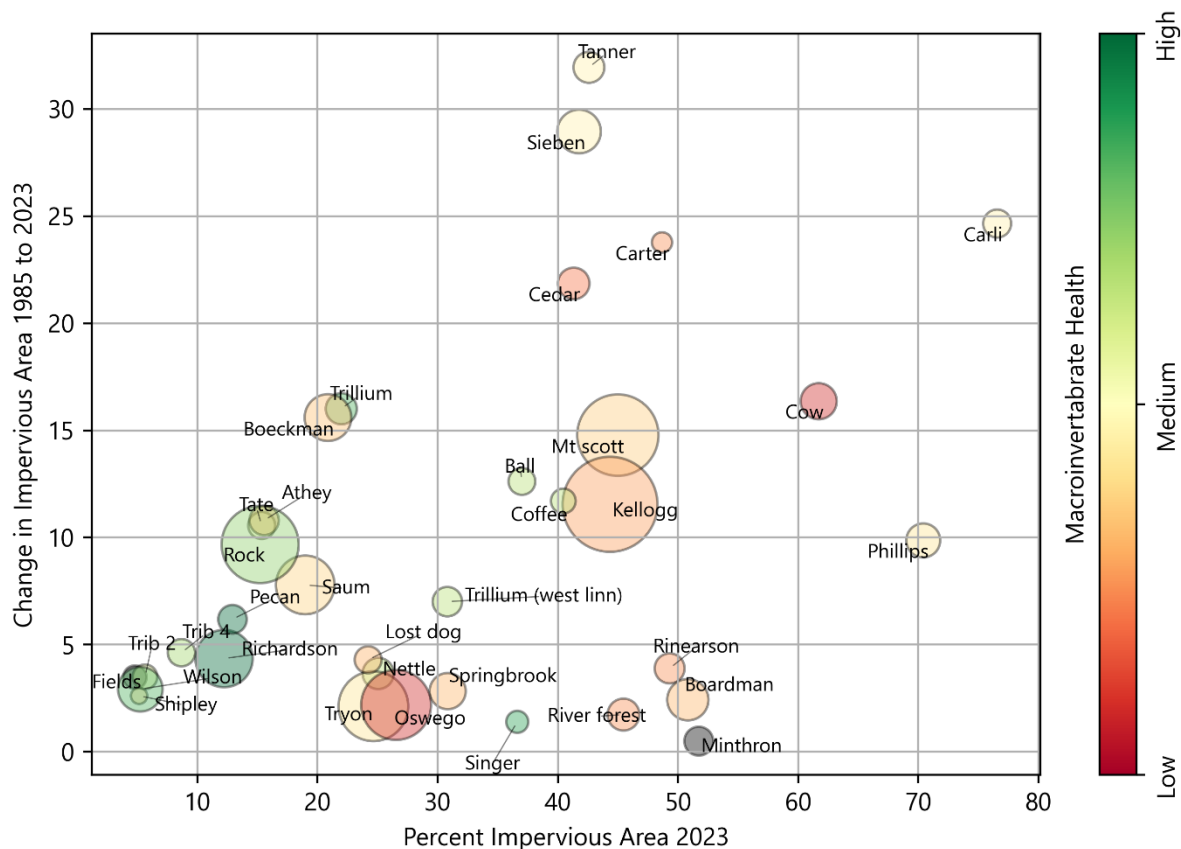
Watersheds at risk of exceeding 70 percent impervious cover include Cow Creek, and Phillips Creek, which are already two of the most developed watersheds today. Among watersheds that are already more than 5 percent impervious, several are projected to experience substantial increases between existing and full buildout conditions, including Trillium Creek with a 120 percent increase, Boeckman Creek with a 128 percent increase, Wilson Creek with a 146 percent increase, and Rock Creek with a 170 percent increase.

Figure 20: Development patterns related to macroinvertebrate health. Macroinvertebrate health is based on the watershed average 2024 macroinvertebrate score (see Scoring section). Marker size is scaled relative to watershed drainage area. Impervious area determined from 1985 and 2023 NLCD datasets.

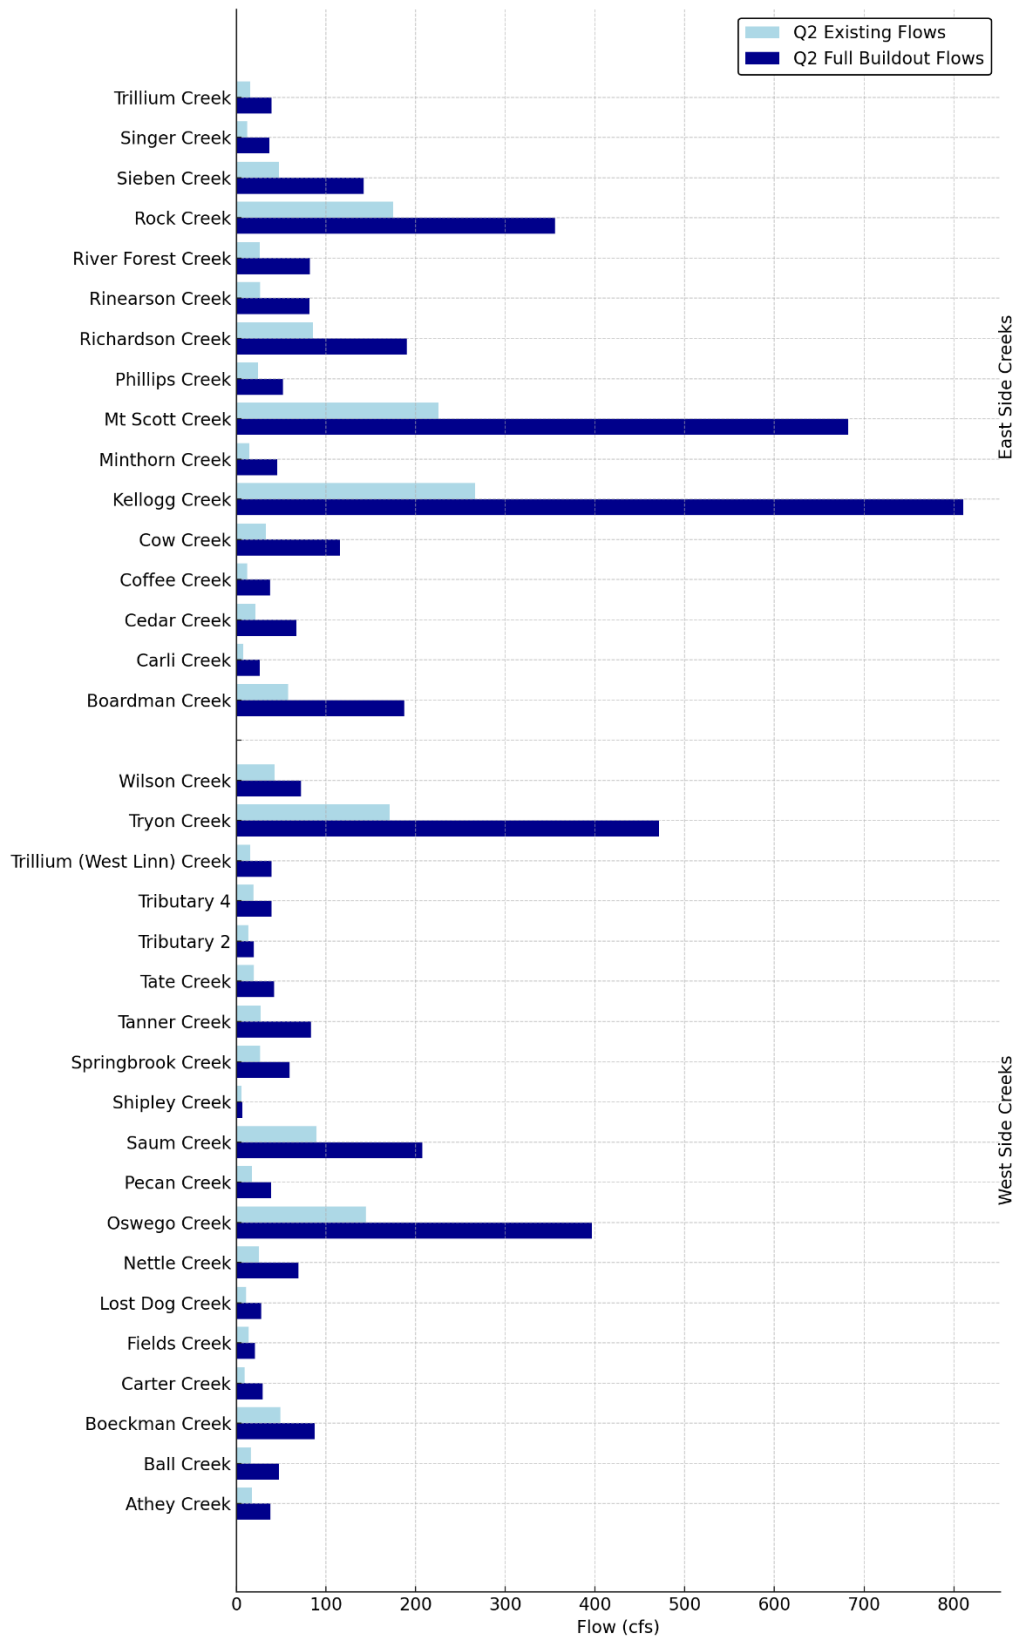
This increase in impervious area will potentially influence peak flows in the study creeks. Figure 21 shows the predicted change in peak flows across the study area with the increased impervious areas. Other than the already most developed streams, Boardman Creek, Rinearson Creek, Carter Creek, and Minthorn Creek are predicted to experience the largest increases in peak flows.

Figure 21: Summary of predicted increase in peak flows across the study area.

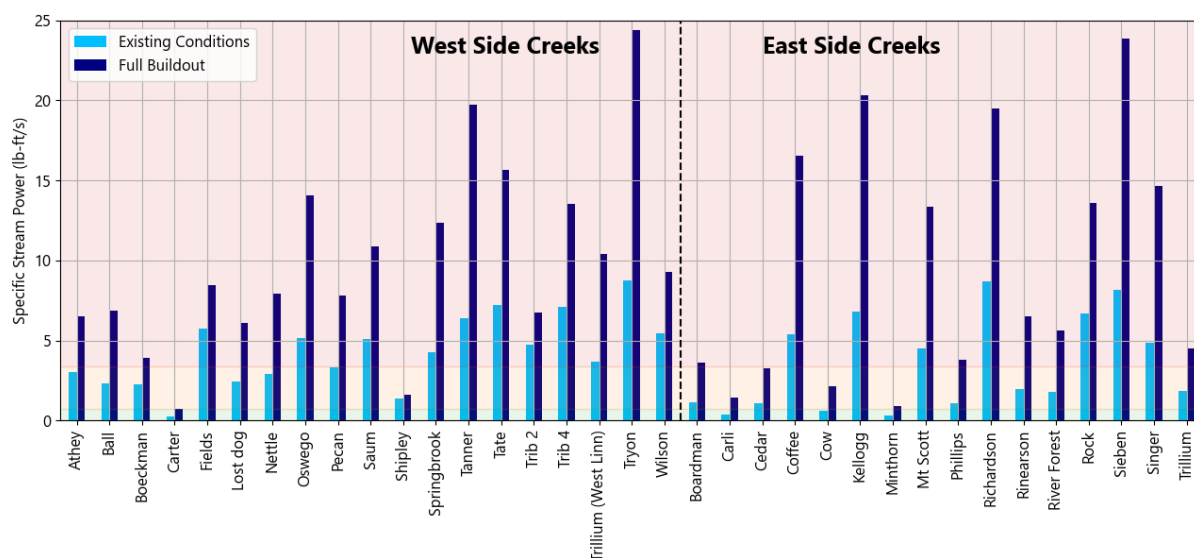
Specific stream power values, calculated using the hydrology described above, were used to assess erosion potential across the study area. Under existing conditions, only four streams (Carli Creek, Carter Creek, Minthorn Creek, and Cow Creek) fall within the low erosion potential category (Figure 22). Thirteen streams fall into the medium category and another eighteen fall into the high category. Tryon Creek exhibits the highest specific stream power under current conditions, with Richardson and Seiben Creeks not far behind.

Figure 22: Stream power results for each stream under existing conditions and full buildout conditions. Green represents low erosion potential, yellow represents medium erosion potential, and red represents high erosion potential.

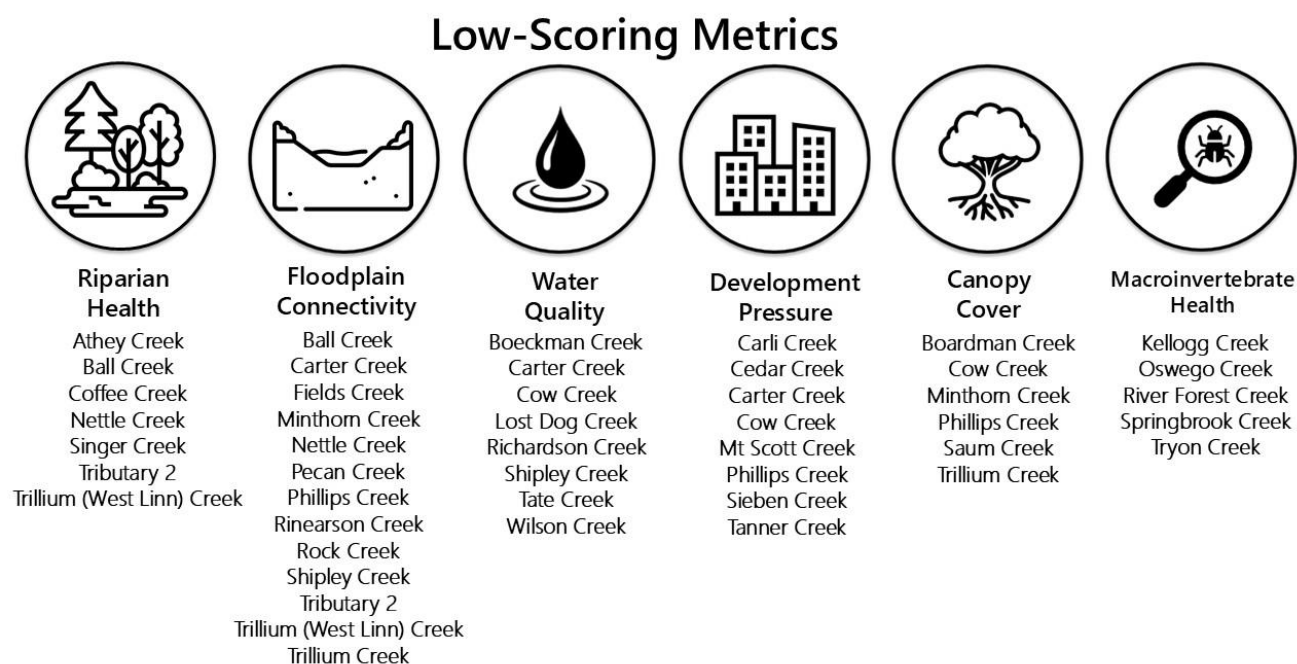
As shown in Figure 23, floodplain connectivity is a common limiting factor, with over one-third of the streams having it as their lowest scoring metric. This is consistent with expectations for urban streams, where hydromodification increases stream energy and alters flow regimes, resulting in more frequent and intense erosive events that degrade channel and floodplain connections. Water quality is the next most frequently identified low-scoring metric, suggesting possible pollution concerns across the study area, likely influenced by stormwater runoff and other impacts associated with urbanization.

Figure 23: Graphic listing lowest scoring metric for each creek. Some creeks are listed for more than one metric.

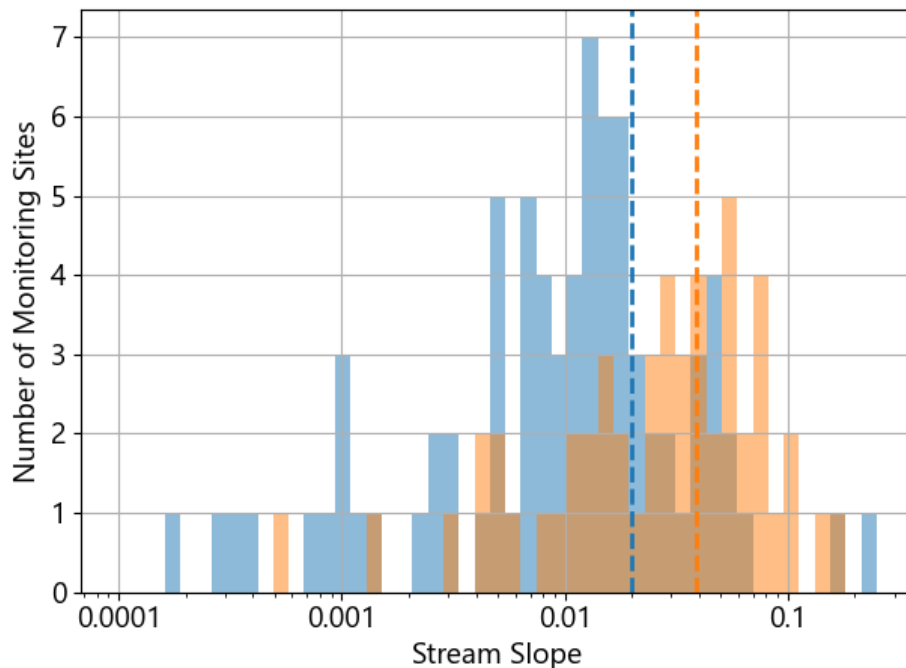
The difference in geology and, consequently, stream slope between East and West streams is visualized in Figure 24; the average West-side stream is twice as steep (~4%) as the average East-side stream (~2%). Lower gradient streams, but not slack water, yields more hyporheic mixing, gravel substrate, and floodplain connectivity – which all benefit macroinvertebrate communities.

Figure 24: Histograms comparing water surface slope (ft/ft) of monitoring sites between East and West sites. Dashed lines represent the sample means.

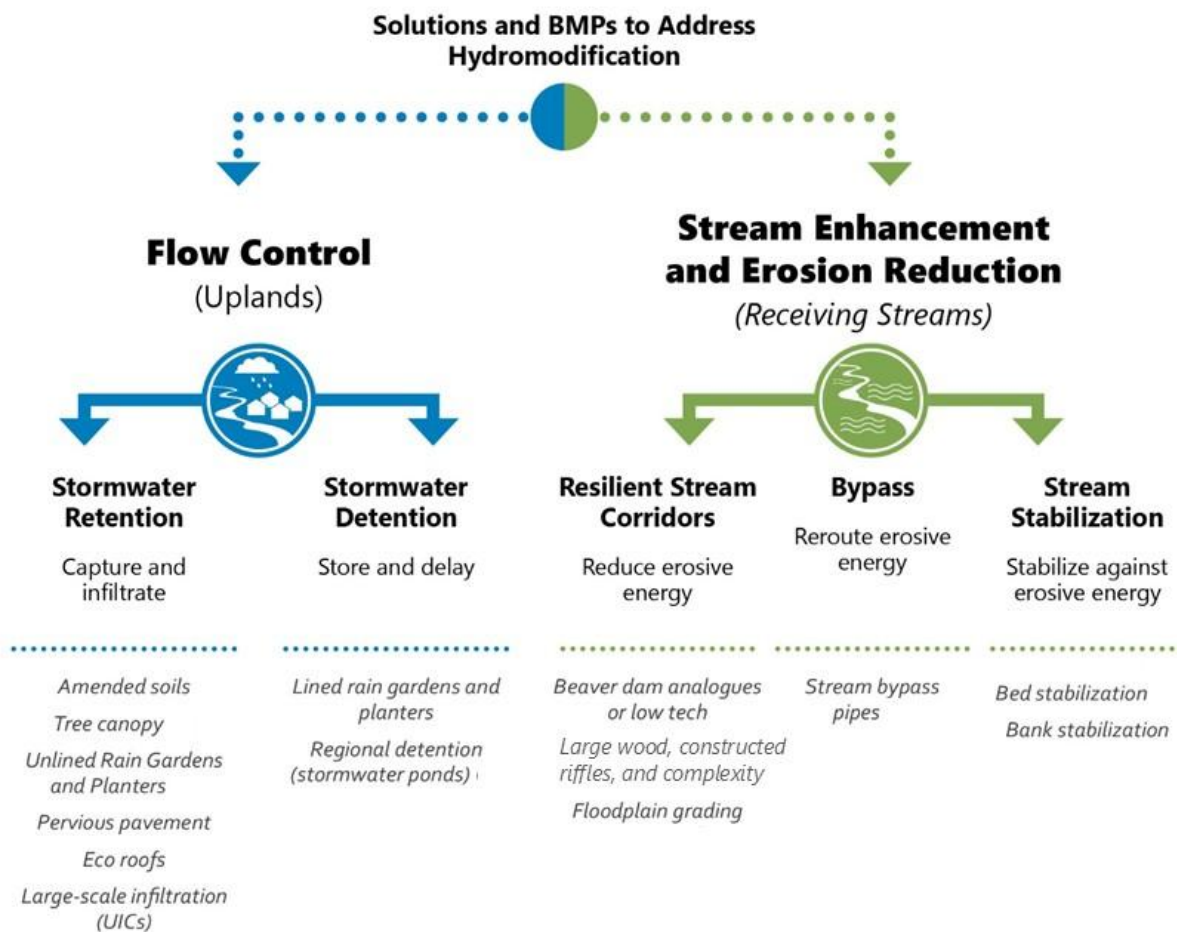
Figure 25: Classification of solutions and BMPs commonly used to address hydromodification and its impacts.

To address these challenges, the following presents a variety of strategies aimed at improving stream conditions. Recommendations are provided for both the Co-Permittees and private landowners, recognizing that effective watershed management depends on collaboration across public and private sectors. As previously discussed, understanding and addressing the impacts of hydromodification is a critical component of watershed management for urban streams. There are different approaches, or best management practices (BMPs) to hydromodification solutions, with upland flow control and stream enhancement being the two fundamental categories. Each of these has multiple subcategories that further define the possible goals and solutions within a hydromodification strategy (Figure 25). An integrated strategy will utilize multiple of these solutions depending on local and system scale needs.

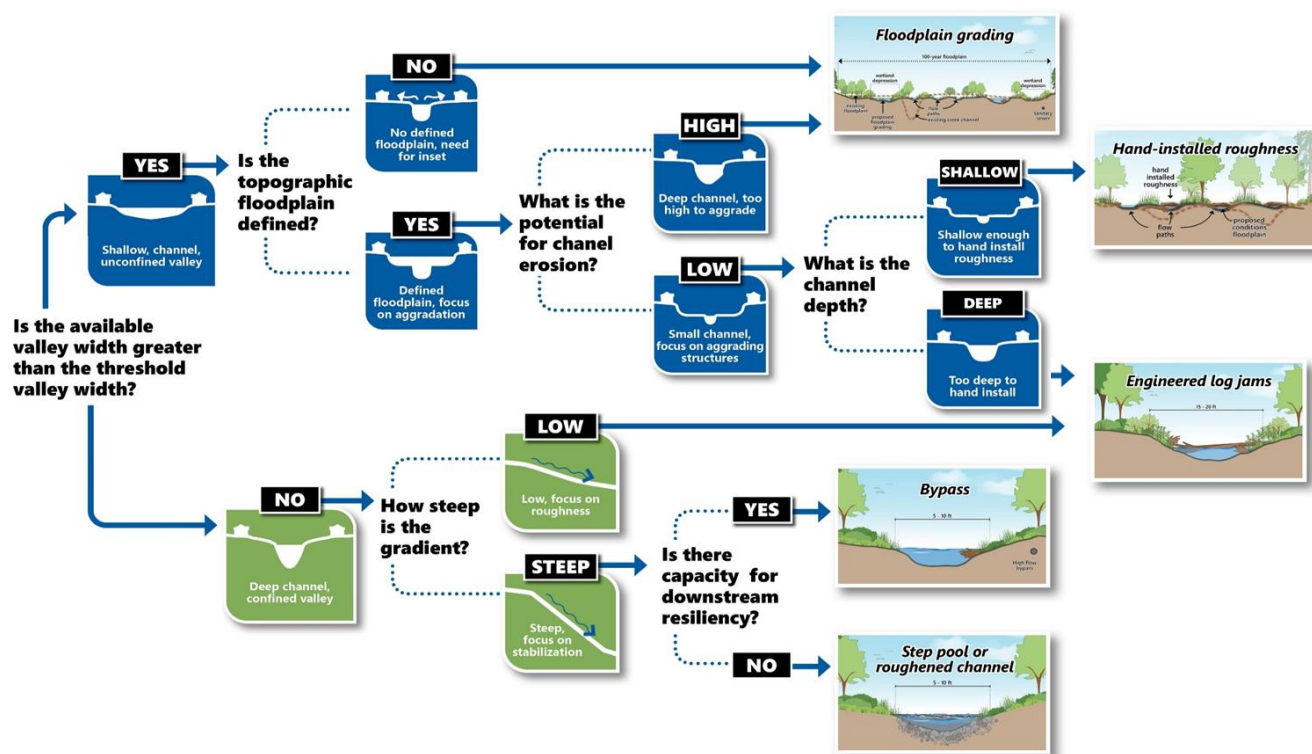
Figure 26: Decision tree for determining feasible restoration actions.

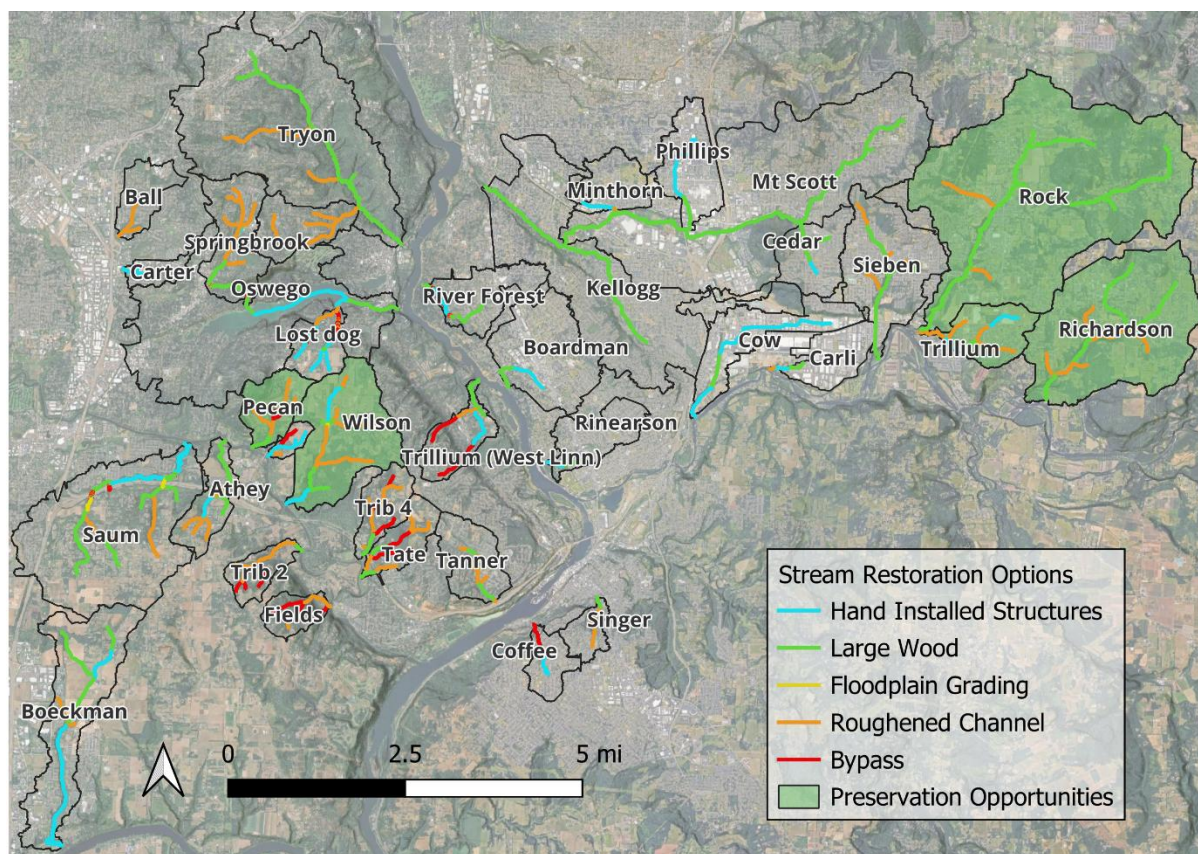
Figure 28: Potential stream restoration options based on feasibility.

Improved floodplain connection not only reduces stream energy during high flows, helping to limit erosion and promote sediment deposition, but also supports more stable channel morphology. These physical changes increase habitat complexity, which is essential for supporting diverse and healthy biological communities.

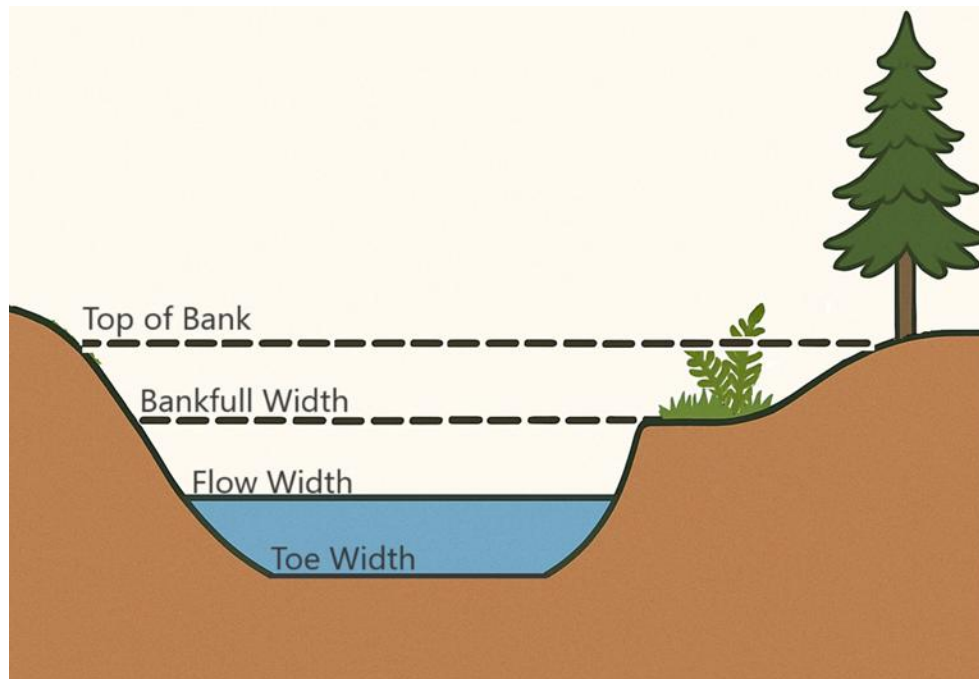
Figure 1: Schematic of channel geometry measurements taken in the field.

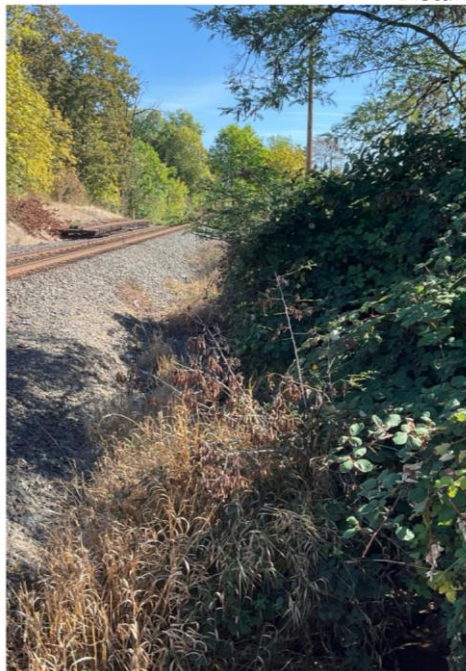
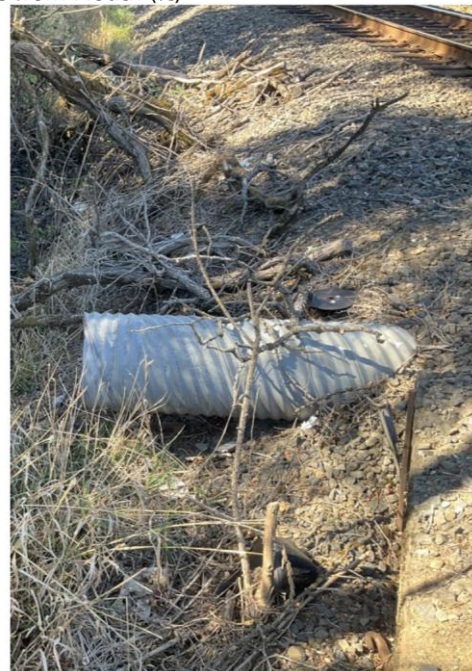
Minthorn Creek

The creek exhibits very limited floodplain connectivity and is heavily impacted by surrounding infrastructure. Canopy cover is minimal. The site visited in 2024, located adjacent to railroad tracks, showed severe ecological degradation and lacked active surface flow, preventing the collection of macroinvertebrate samples and water quality measurements.
